# INFORME CHC

## ATAQUE DOS CLORETOS NO CONCRETO ARMADO

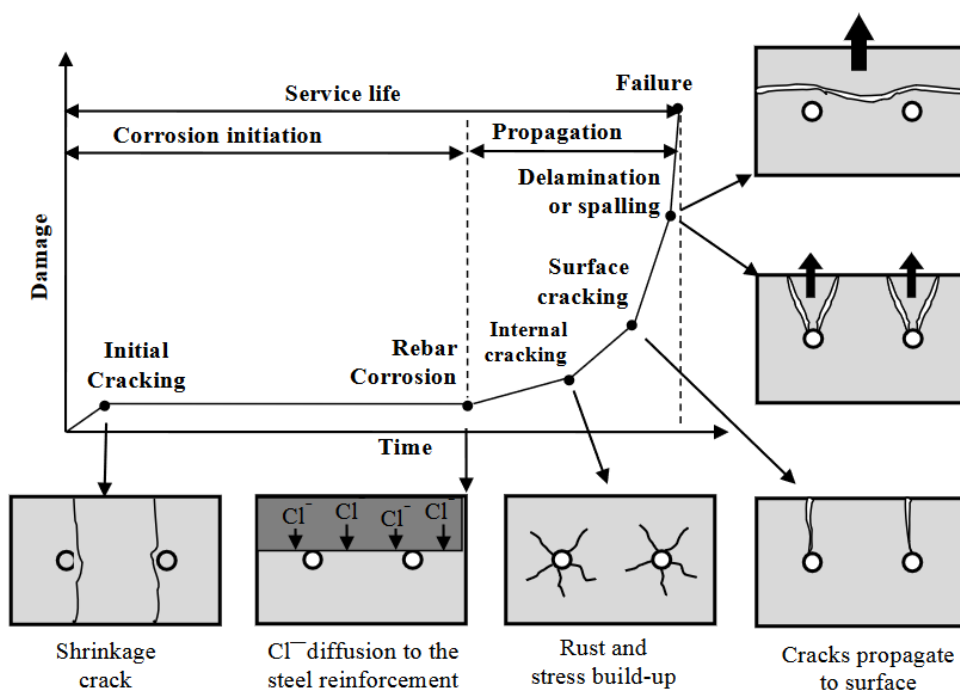
Figure 11. Schematic of corrosion of the steel reinforcement due to external chloride ions (on the left side) diffusing to the steel reinforcement, leading to expansive corrosion products and, eventually, cracking (adapted from Yang et al. 2012).
