Ontario Structure Inspection Manual (OSIM)

Ministry
of
Transportation

POLICY, PLANNING & STANDARDS DIVISION
ENGINEERING STANDARDS BRANCH
BRIDGE OFFICE
October, 2000

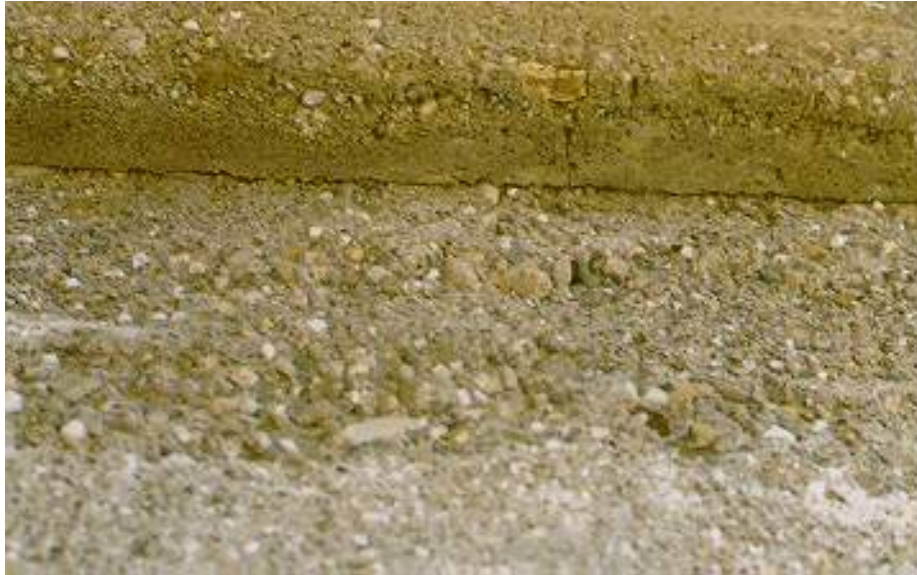
Figure 2.2.1 Severe Scaling in a Concrete Deck and Curb

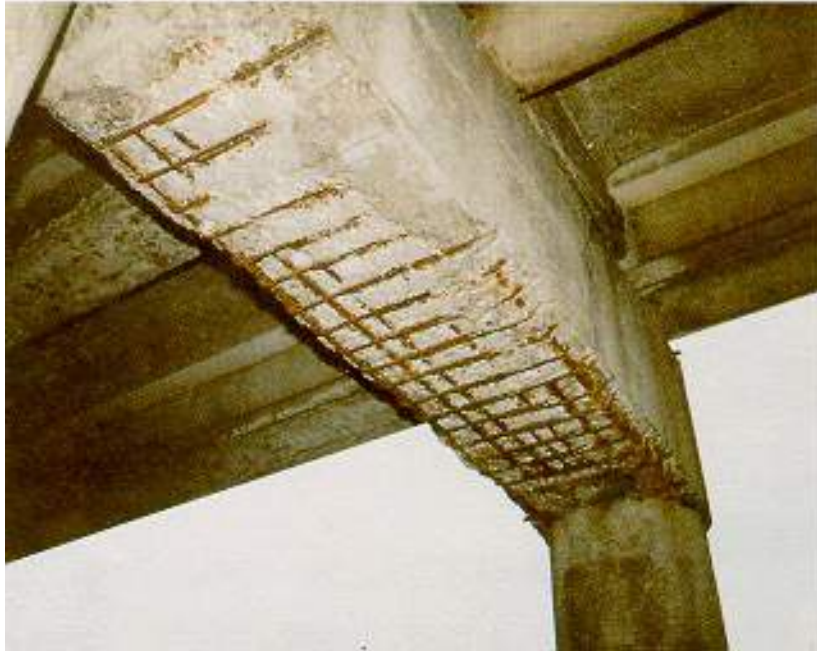
Figure 2.2.6(a) Very Severe Spalling in a Concrete Pier Cap Due to Corrosion of Reinforcement

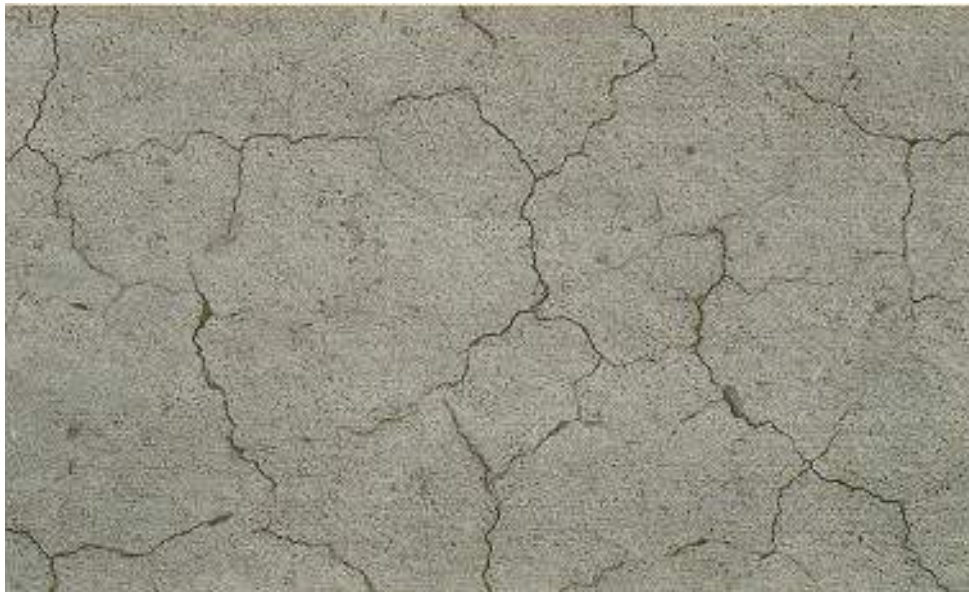
Figure 2.2.8 Severe Alkali-Aggregate Reaction

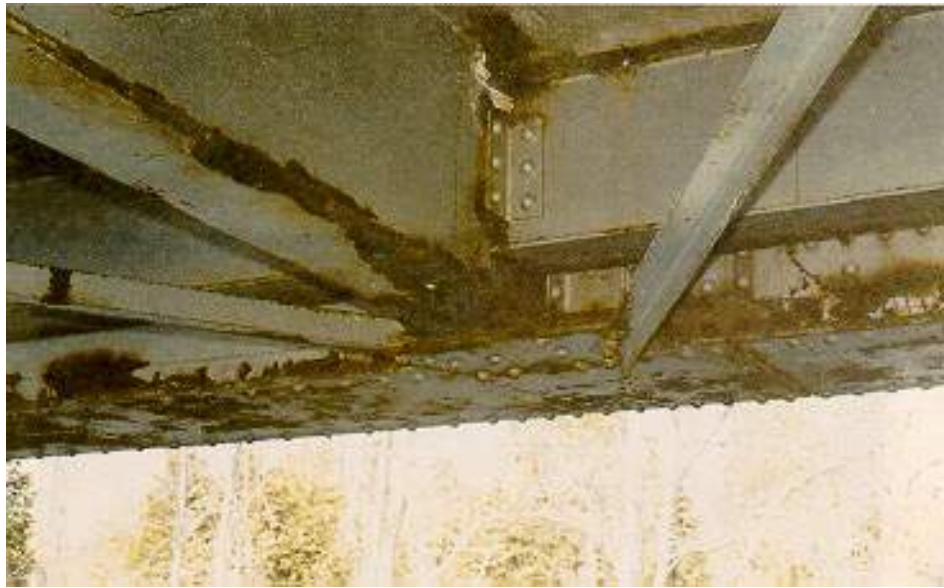
Figure 2.3.1 Medium Corrosion of Steel Beams

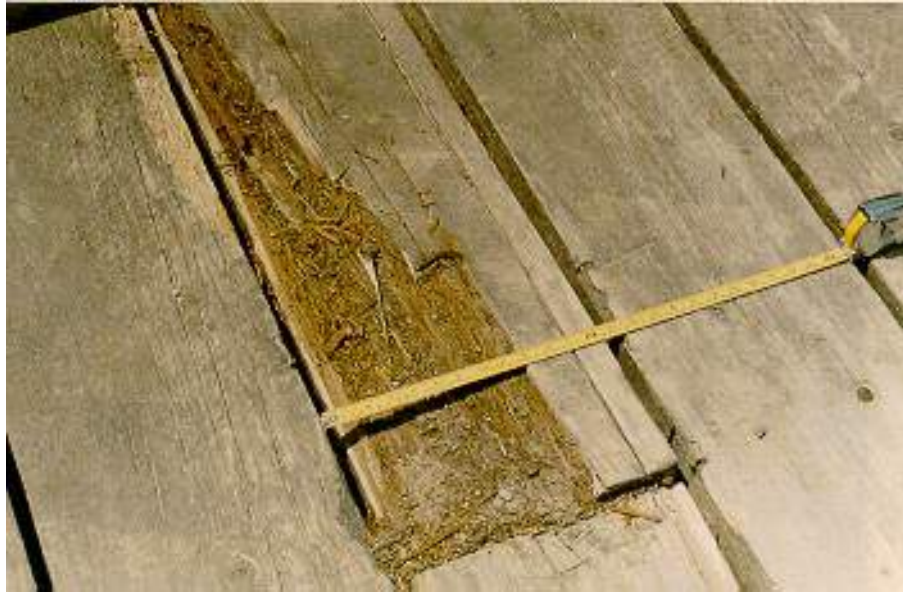
Figure 2.4.2 Very Severe Brown Rot

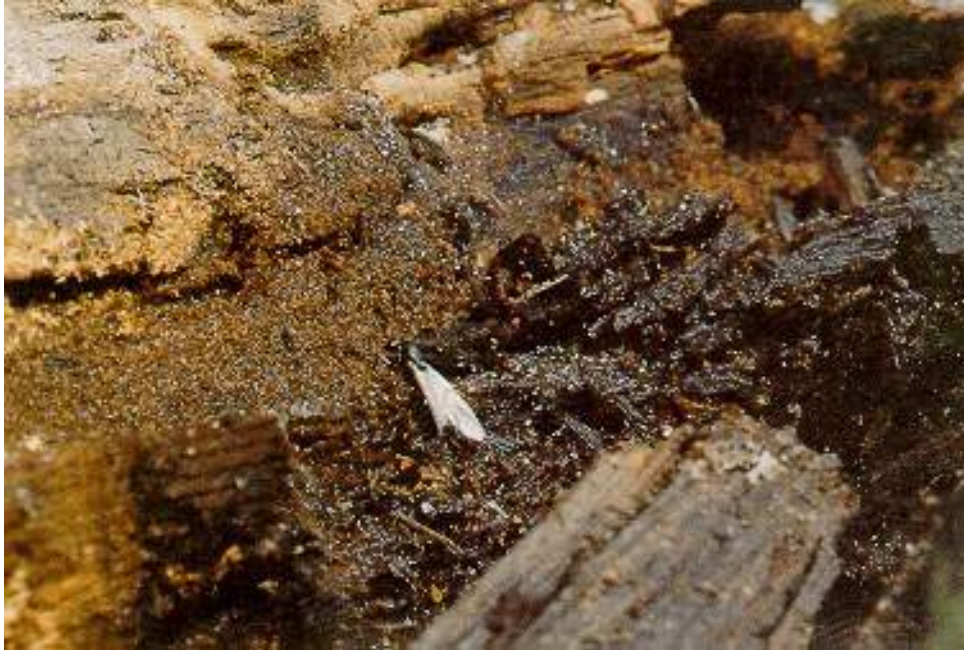
Figure 2.4.3(b) Very Severe Insect Damage in Wood

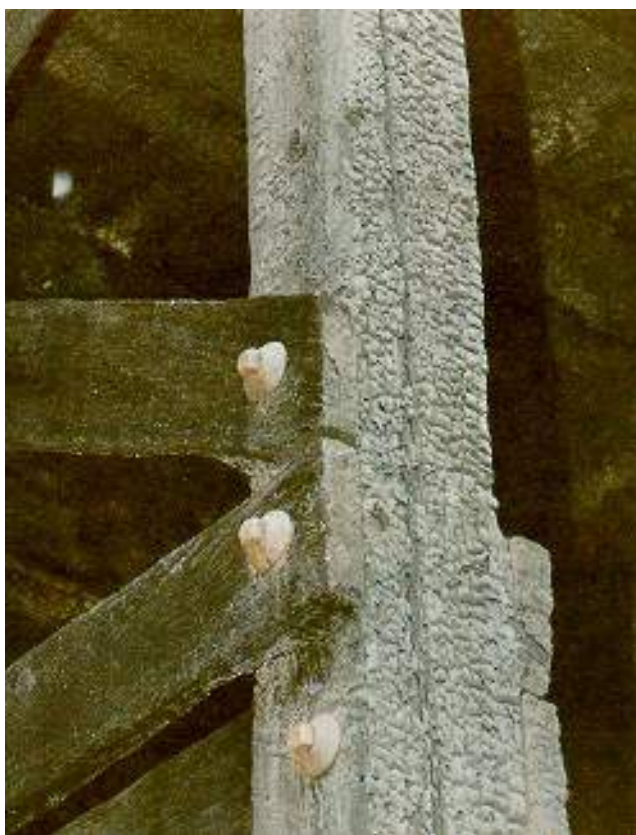
Figure 2.4.6(a) Medium Fire Damage on Wood

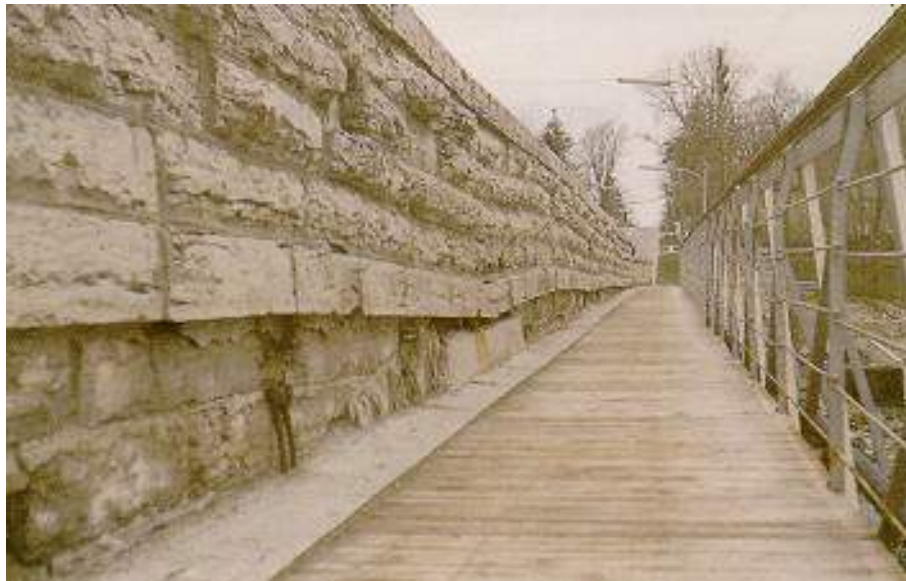
Figure 2.5.2 Very Severe Splitting, Spalling and Deterioration in Masonry.

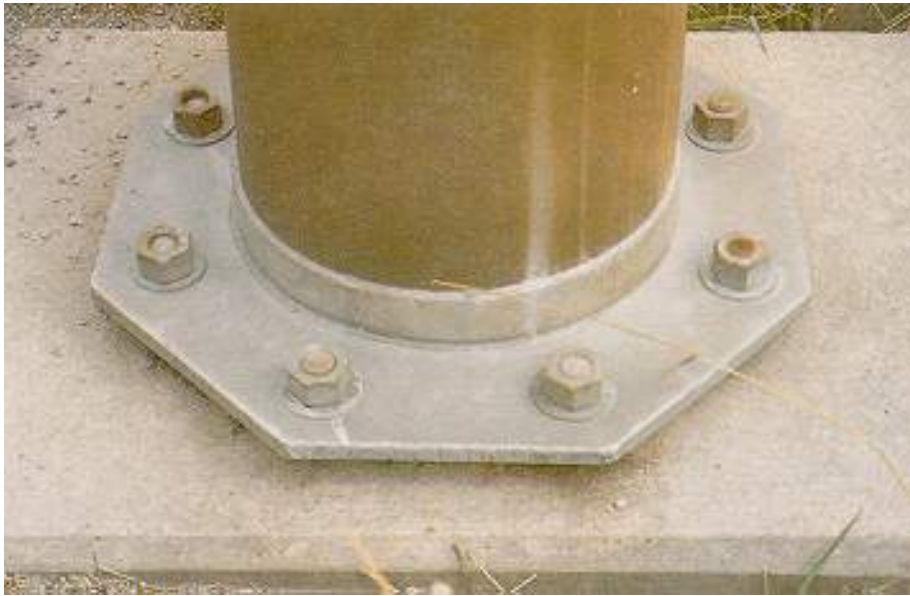
Figure 2.6.1 Light Corrosion

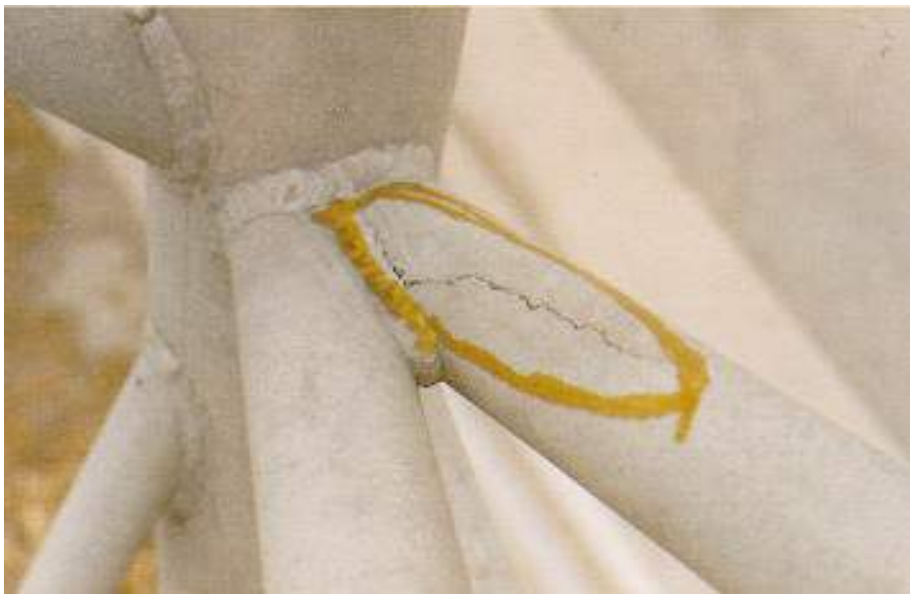
Figure 2.6.2 Wide Crack

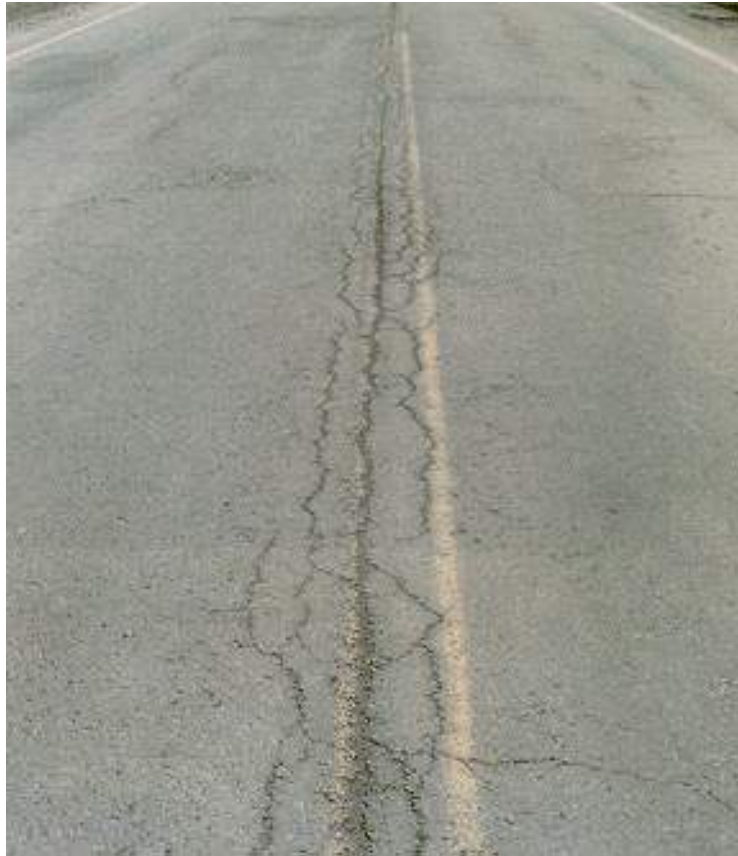
Figure 2.7.1(a) Medium Longitudinal Crack

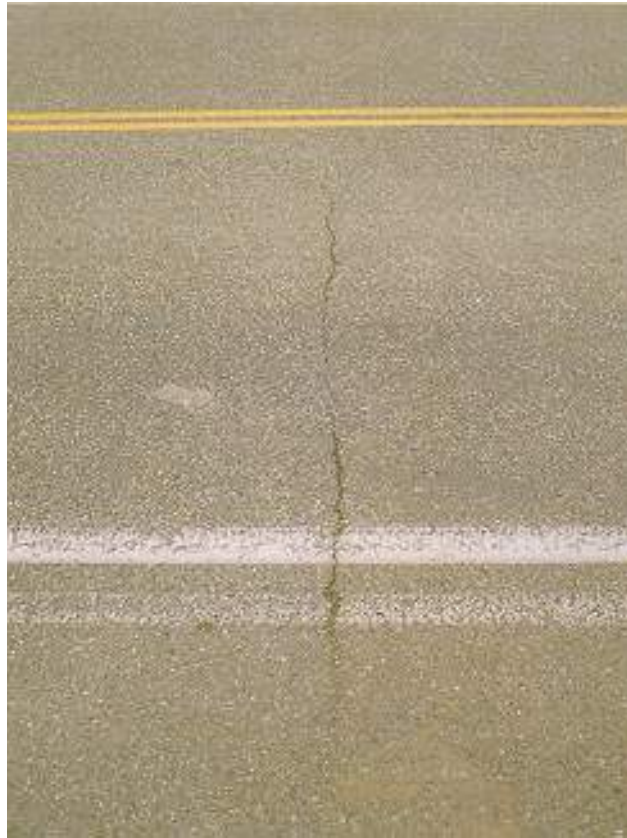
Figure 2.7.1(b) Medium Transverse Crack

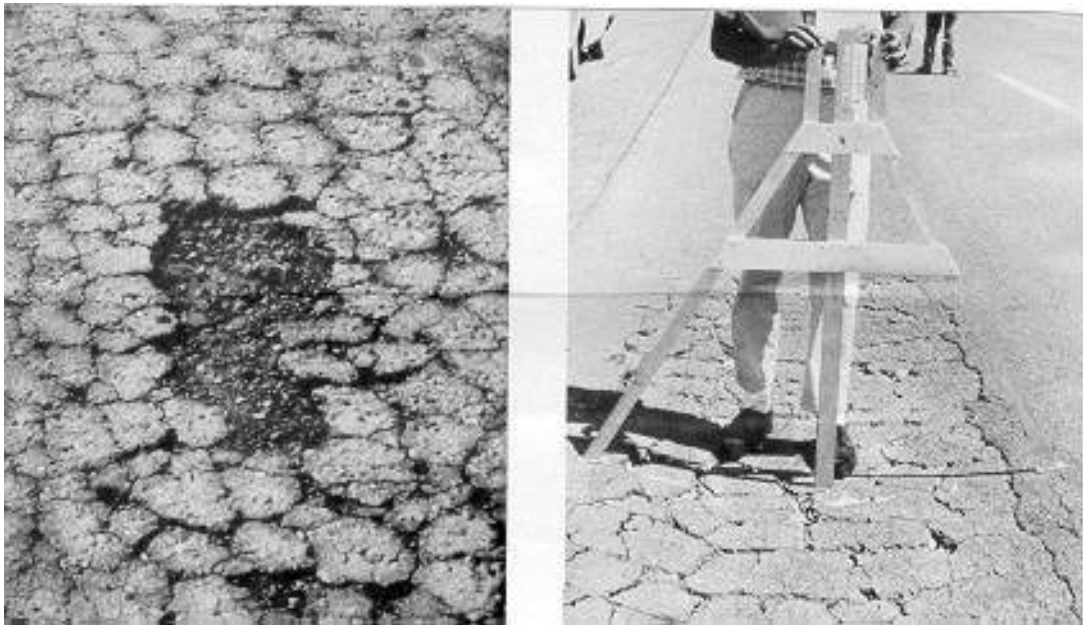
Figure 2.7.1(c) Severe Alligator Cracks

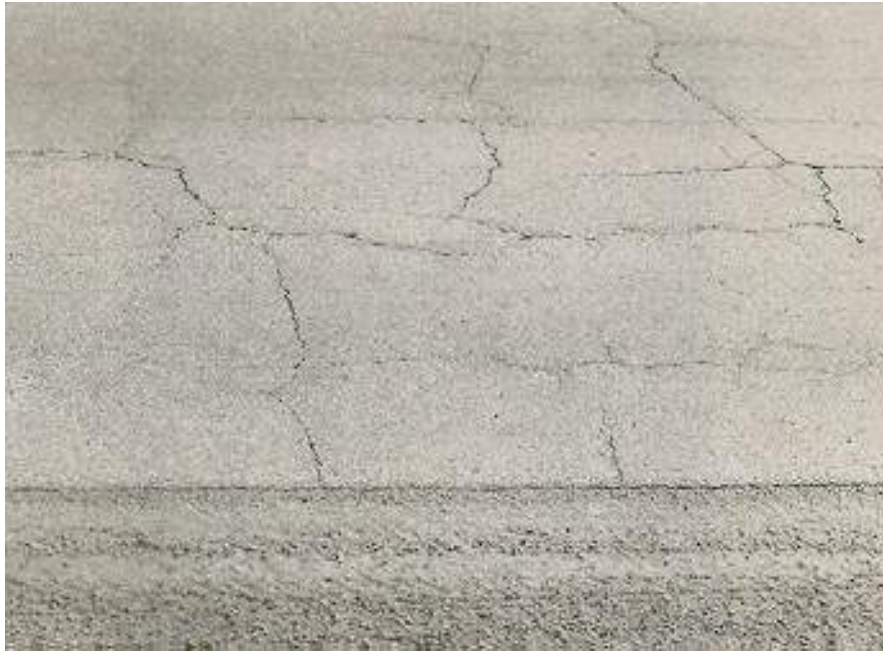
Figure 2.7.1(d) Light Map Cracks

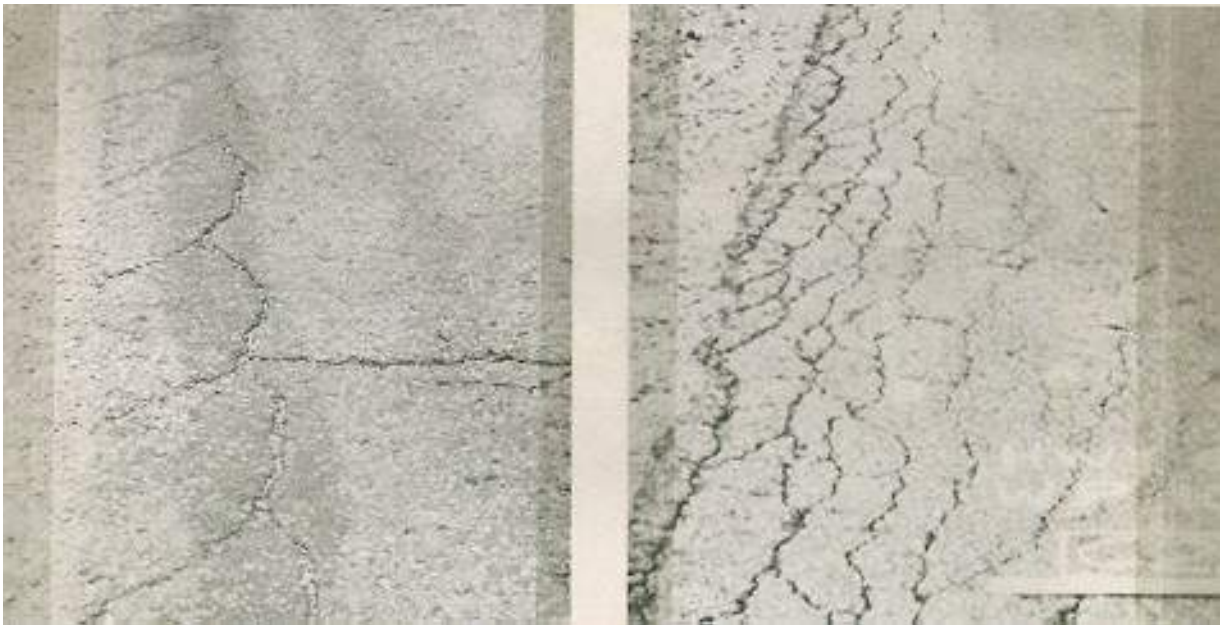
Figure 2.7.1(e) Medium Progressive Edge Cracks

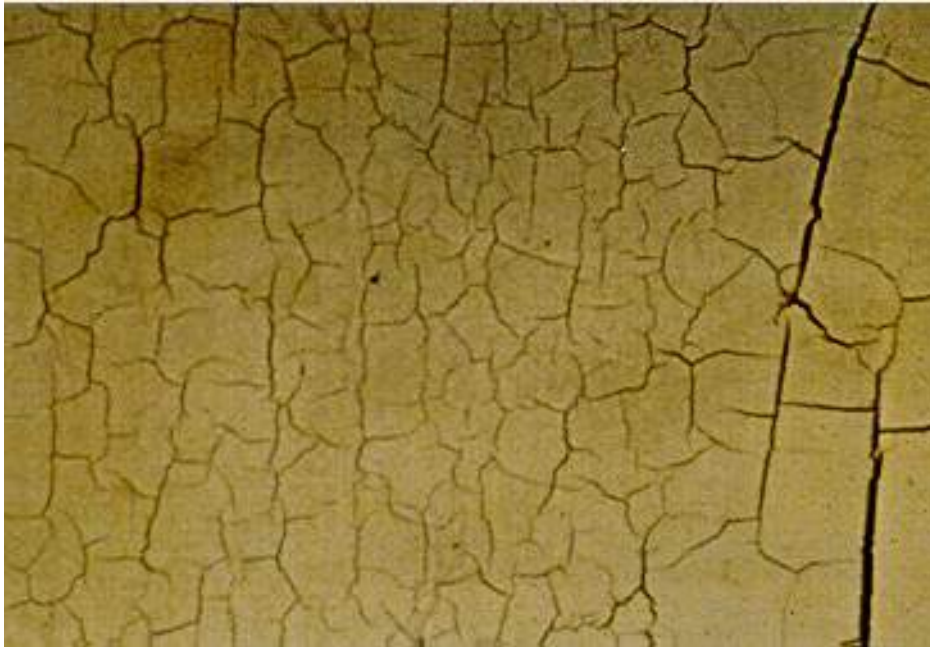
Figure 2.8.1(a) Checking

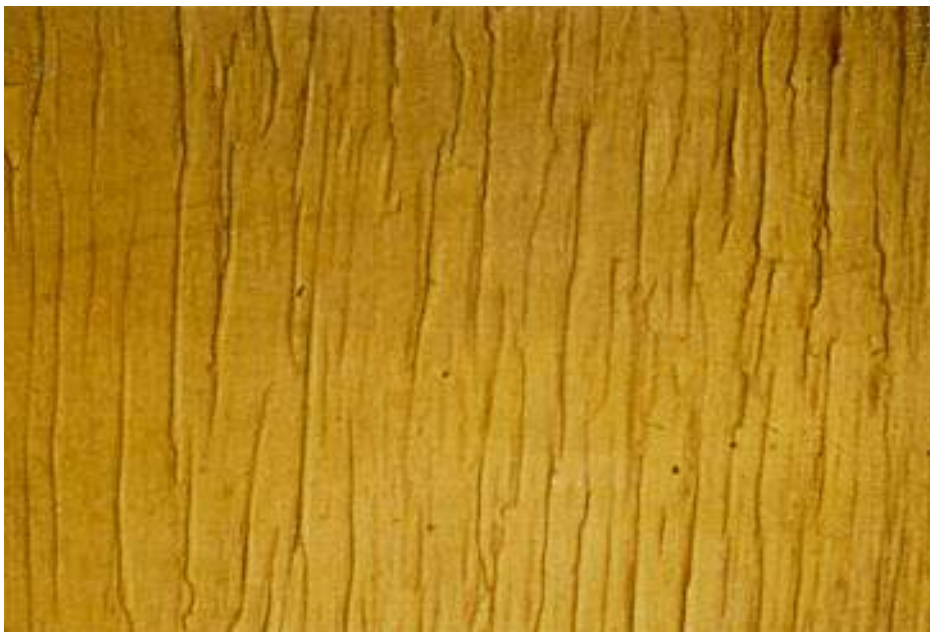
Figure 2.8.1(b) Cracking

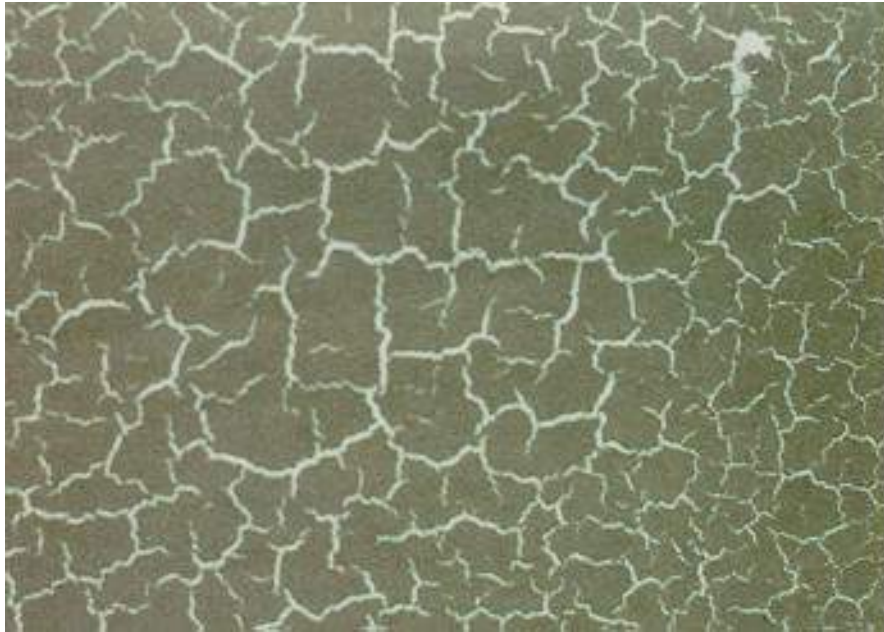
Figure 2.8.1(c) Alligatoring
(typical mud crack pattern)

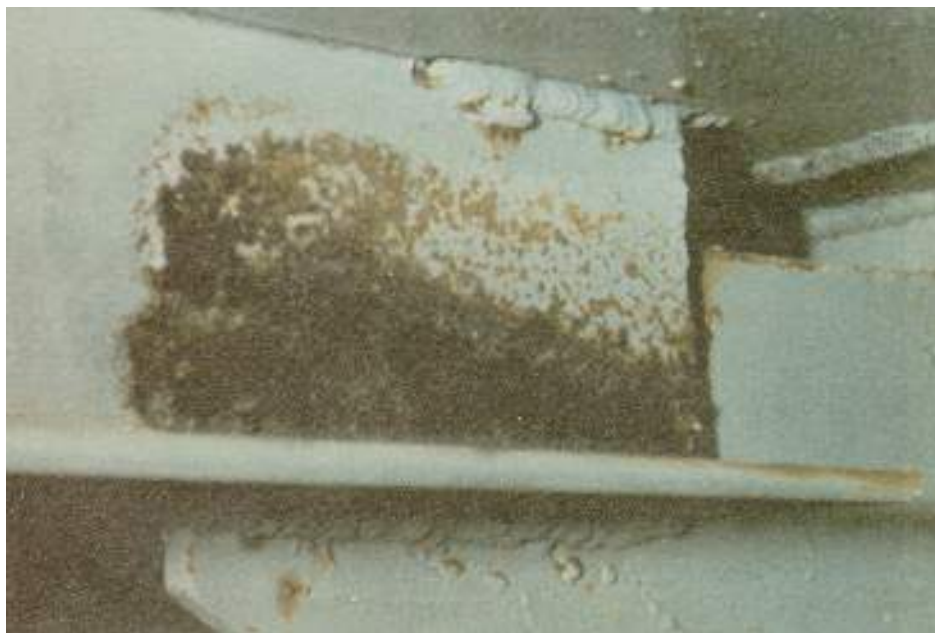
Figure 2.8.1(d) Chemical Attack

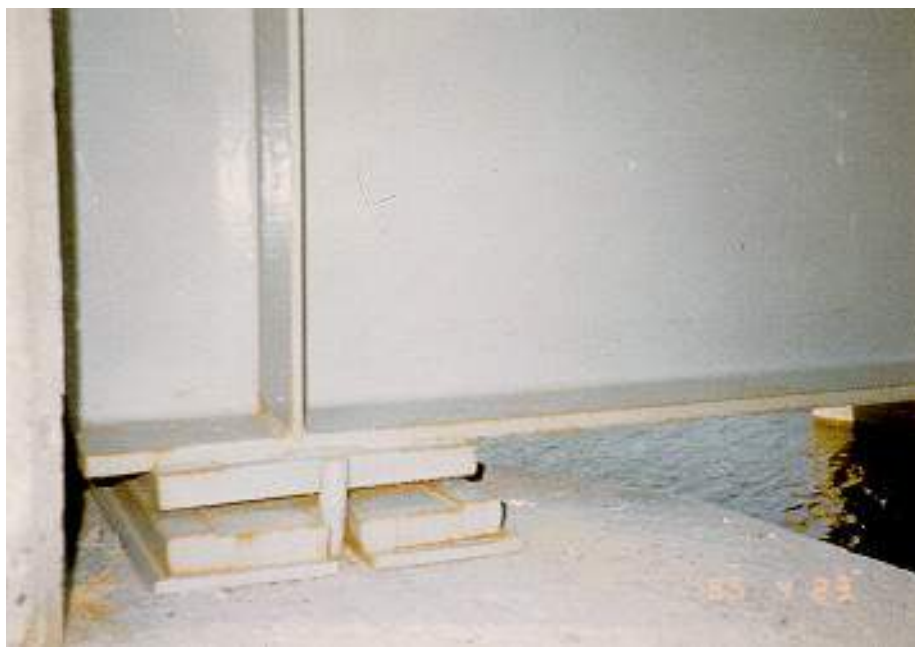
Figure 2.8.3(a) Edge Defects

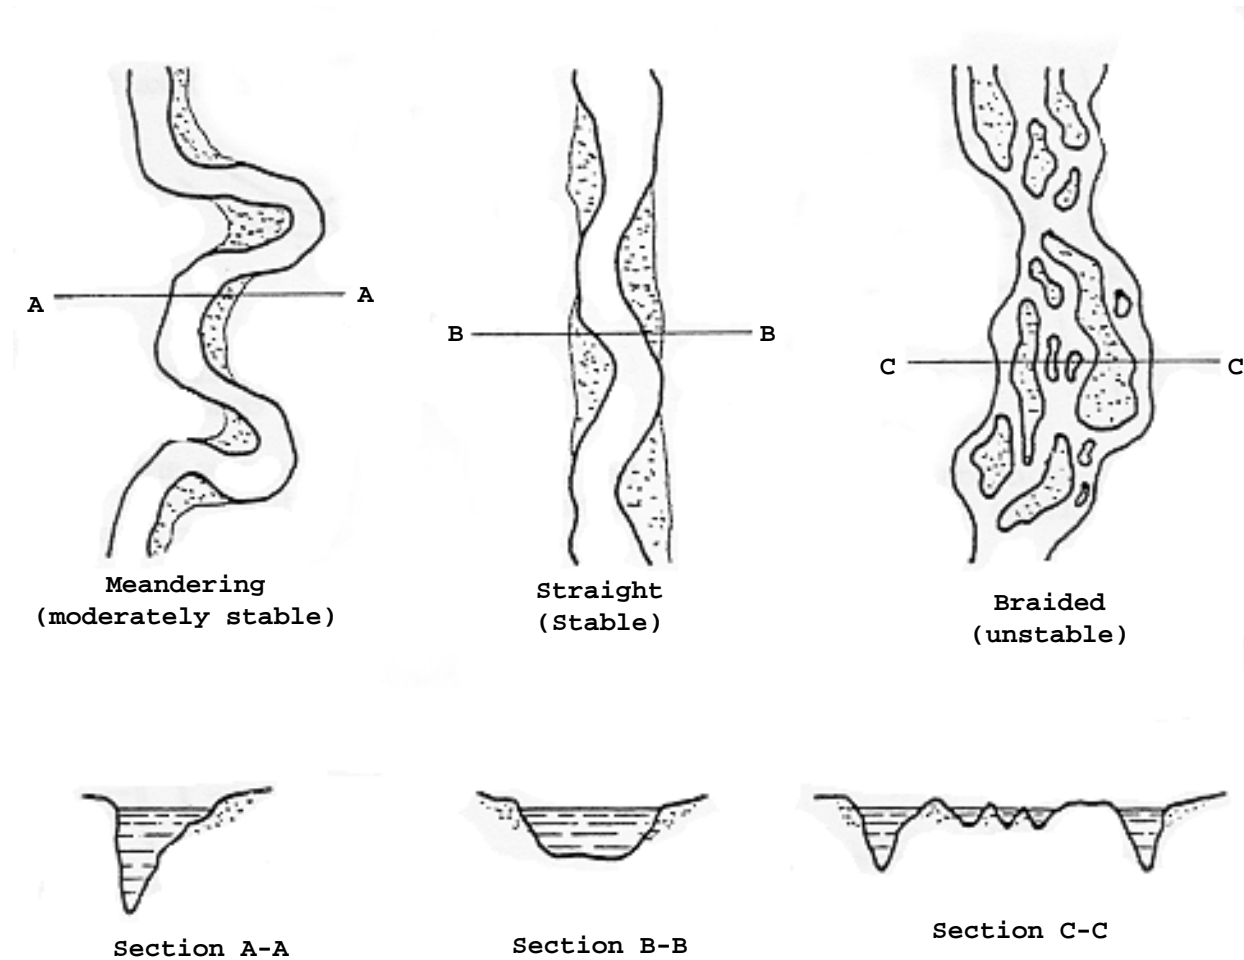
FIGURE 3.1 Principle Types of Streams

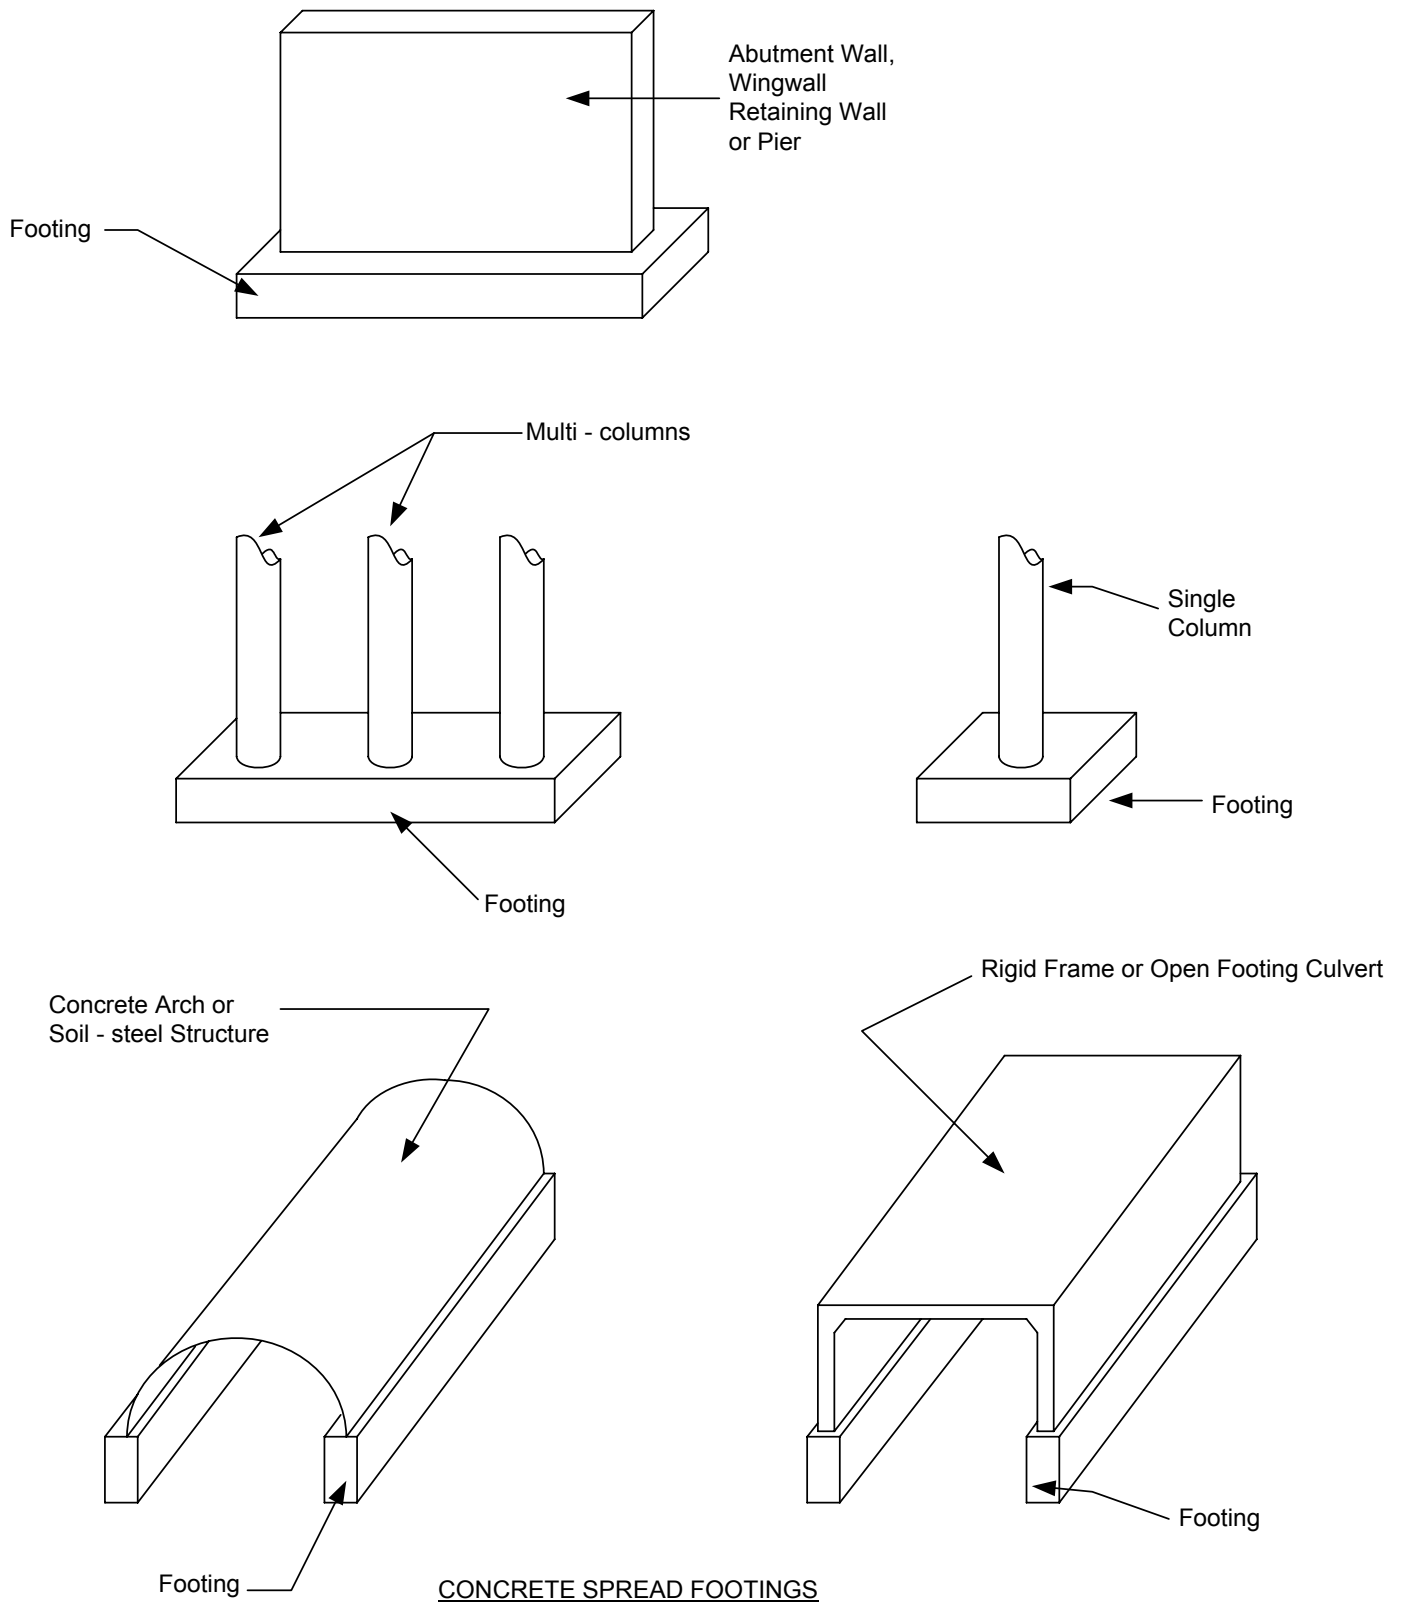
Figure 5.1.1(a) Typical Shallow Foundations

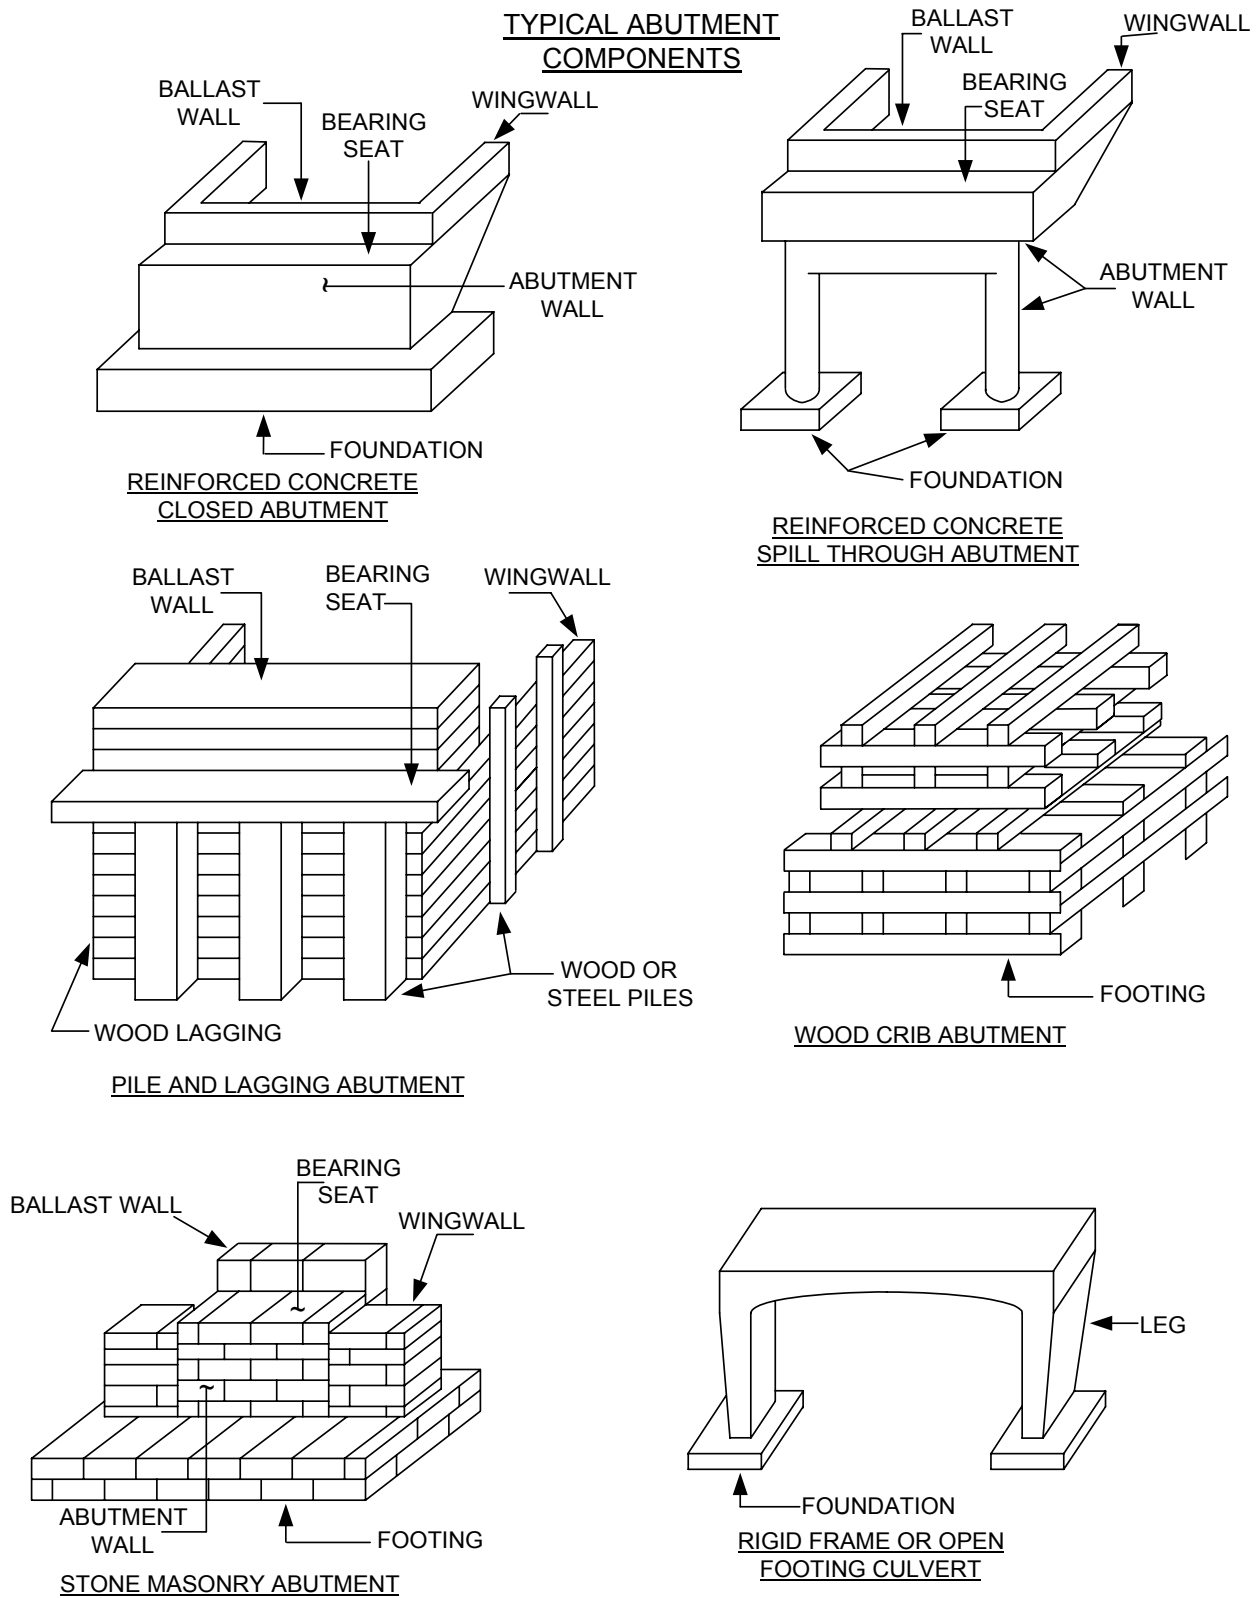
Figure 5.1.2(a) Typical Abutment Components

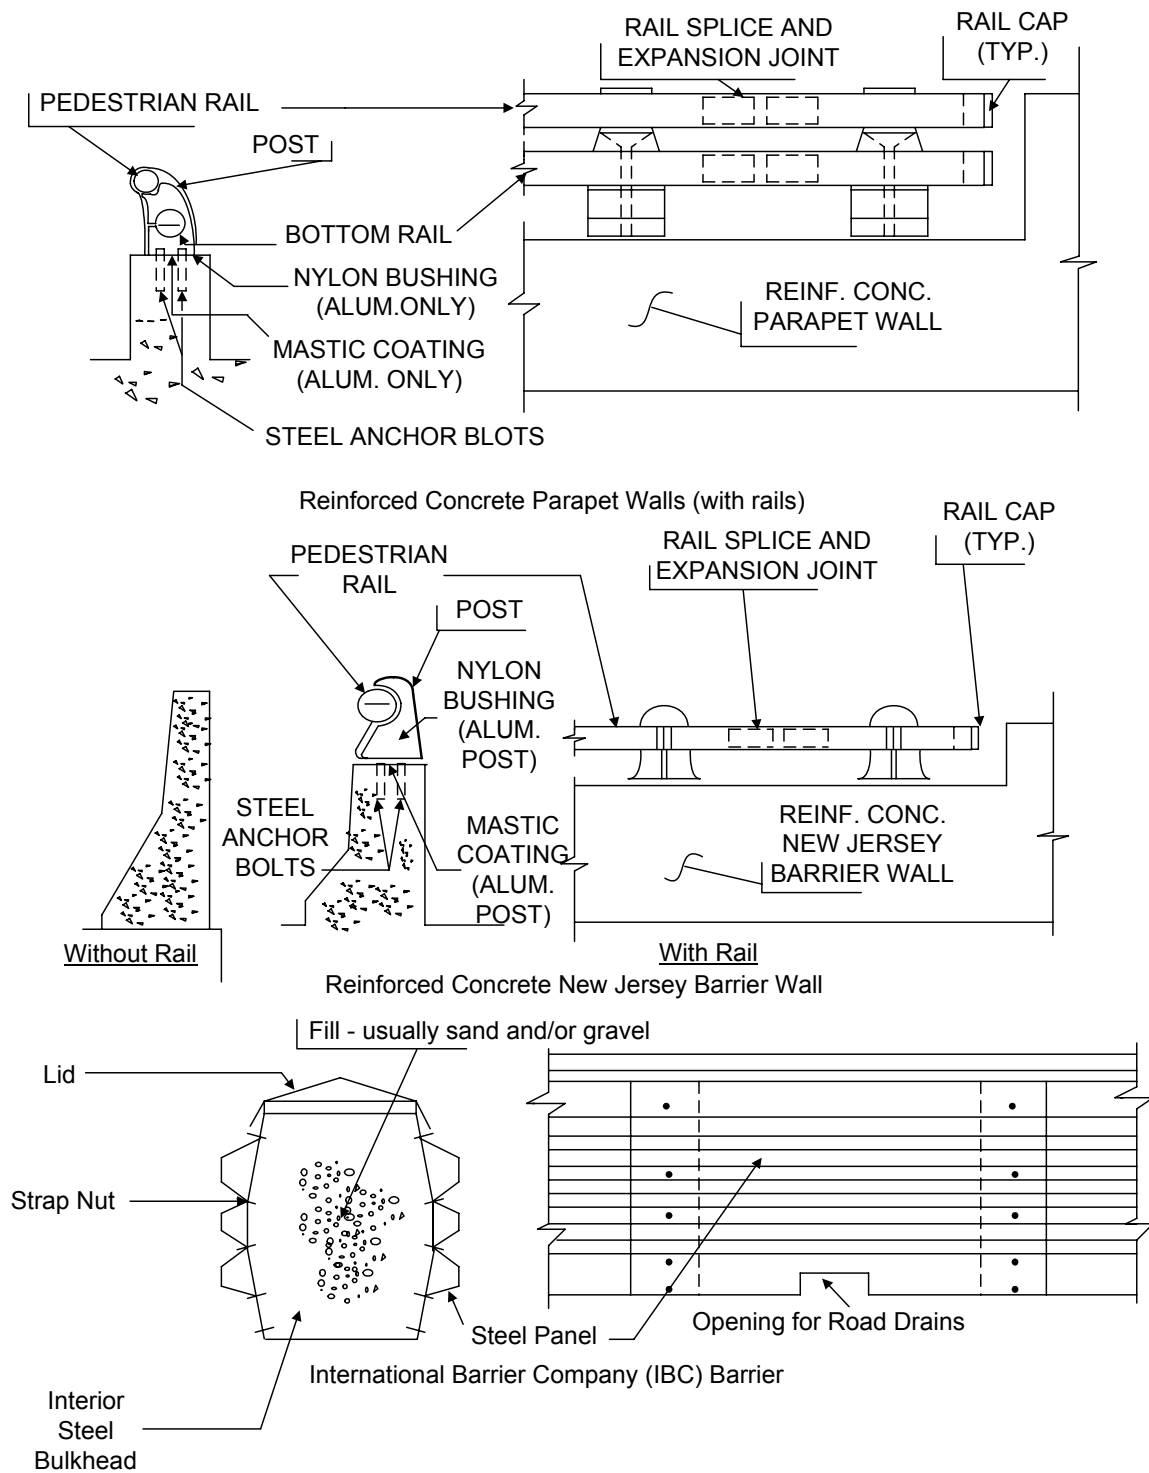
Figure 10.1 Railing Systems

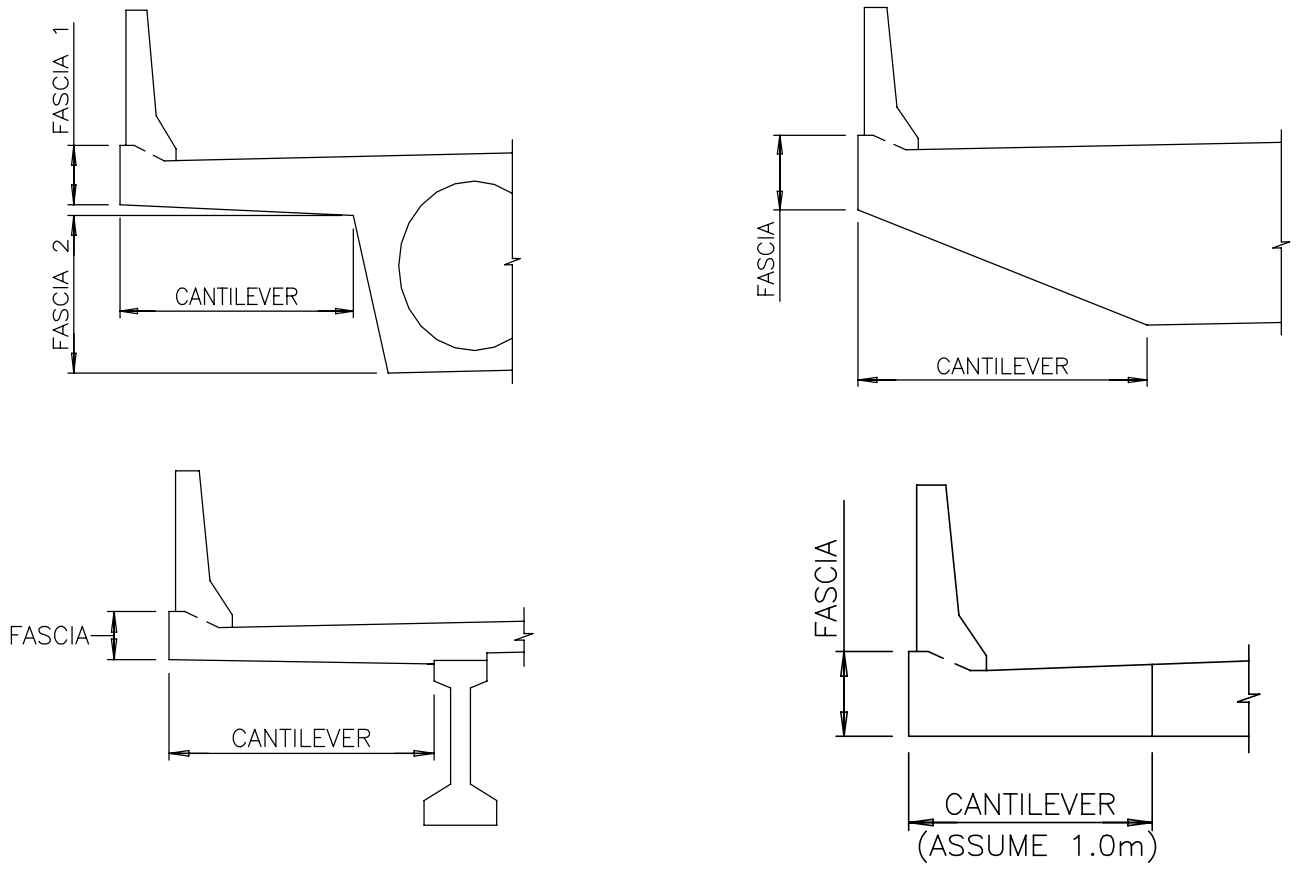
Figure 3.4: Cantilever Definitions

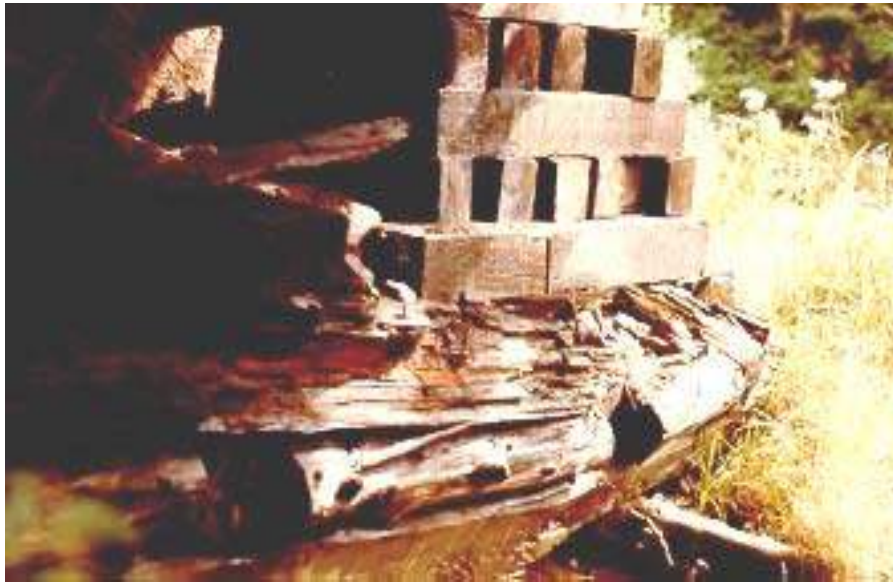
Figure 8.1(c) Wood Crib - Abutment Wall

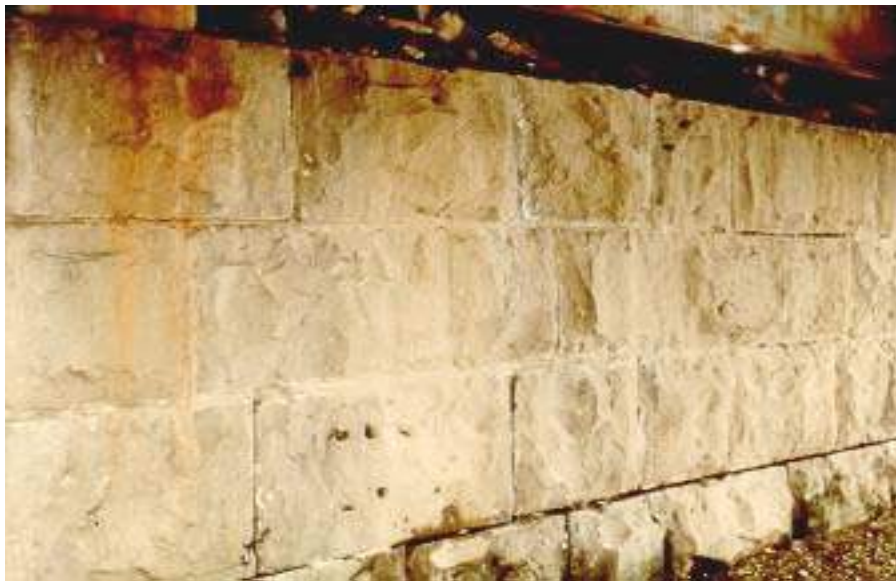
Figure 8.1(d) Masonry Abutment Wall

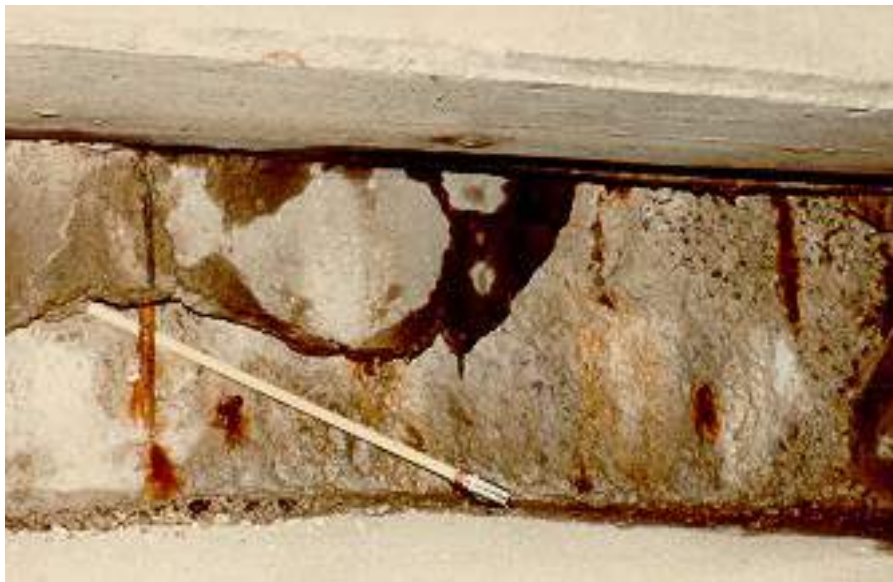
Figure 8.1(h) Concrete Ballast Wall

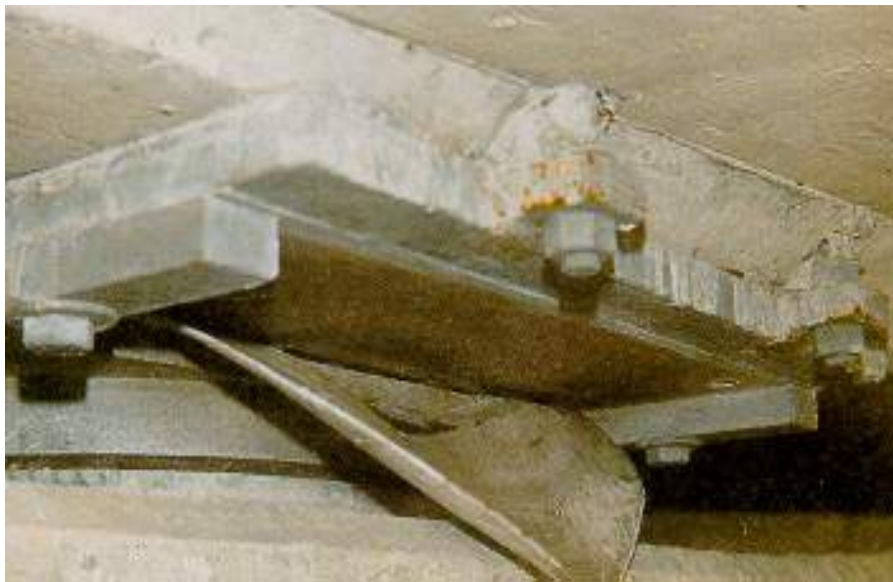
Figure 8.1(l) Pot Bearing

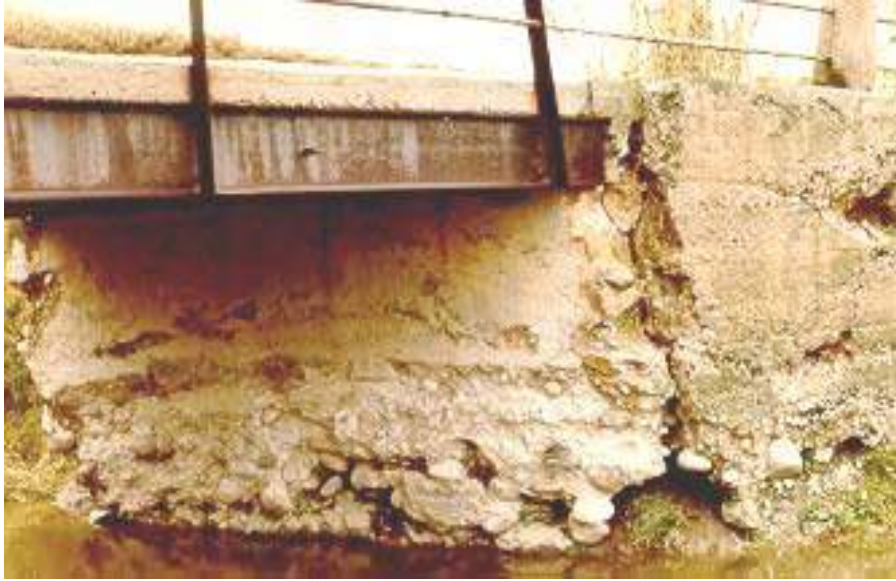
Figure 8.1(q) Concrete Wingwall

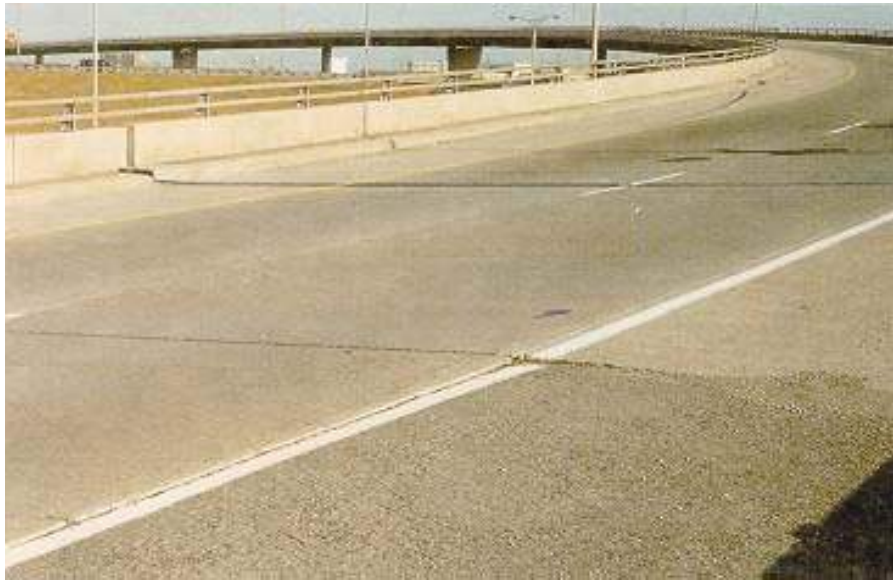
Figure 8.2(a) Concrete Approach Slab
