Ontario Structure Inspection Manual (OSIM)

Ministry
of
Transportation

POLICY, PLANNING & STANDARDS DIVISION
ENGINEERING STANDARDS BRANCH
BRIDGE OFFICE
October, 2000

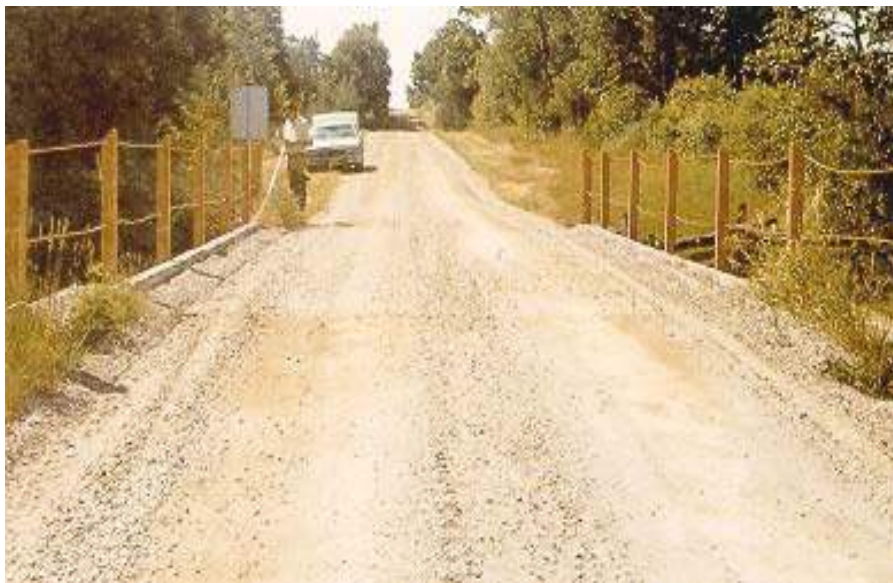
Figure 8.2(f) Gravel Approach

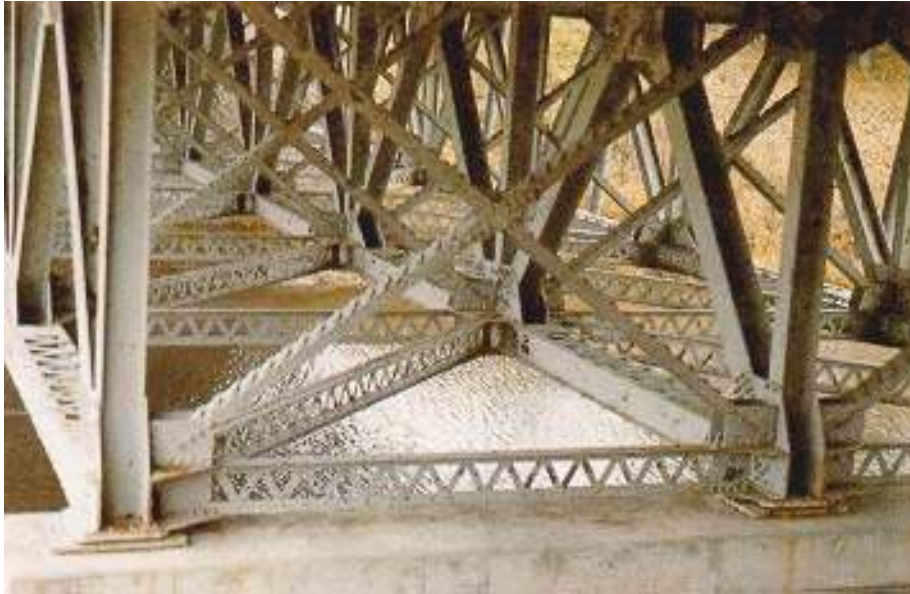
Figure 8.5(a) Sway Bracing and Bottom Lateral Bracing

- Bracings are providing satisfactory lateral support.

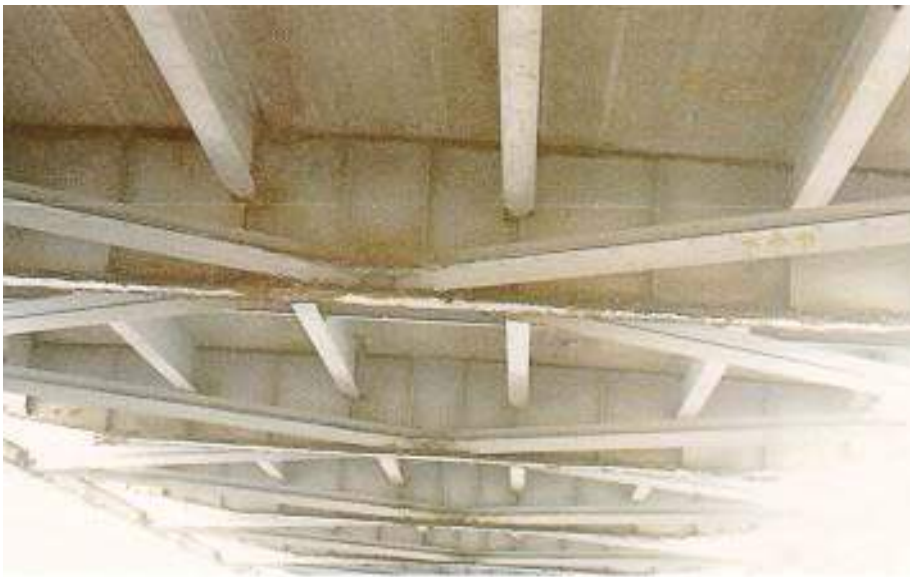
Figure 8.5(b) Bottom Lateral Bracing

- Bracing is providing satisfactory lateral support.

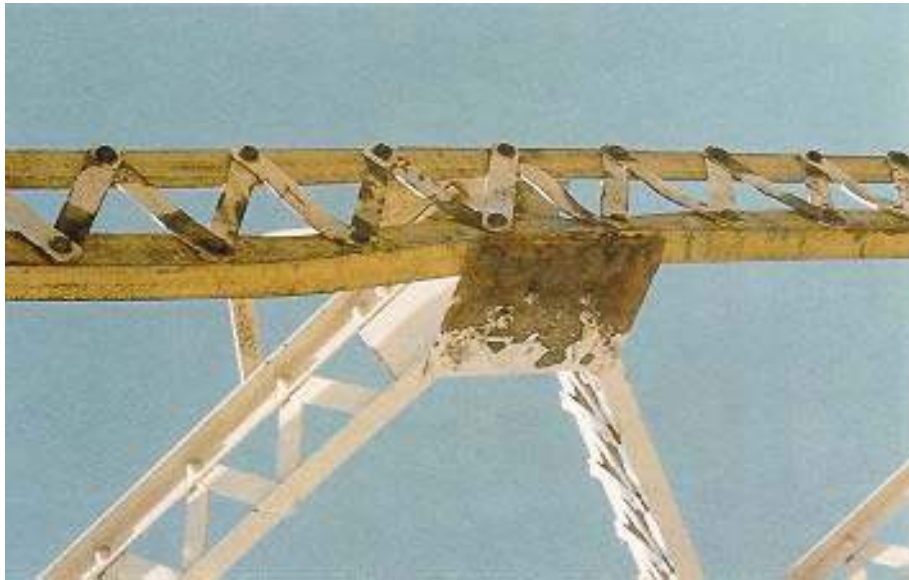
Figure 8.5(c) Top Lateral Bracing in Steel Through Truss

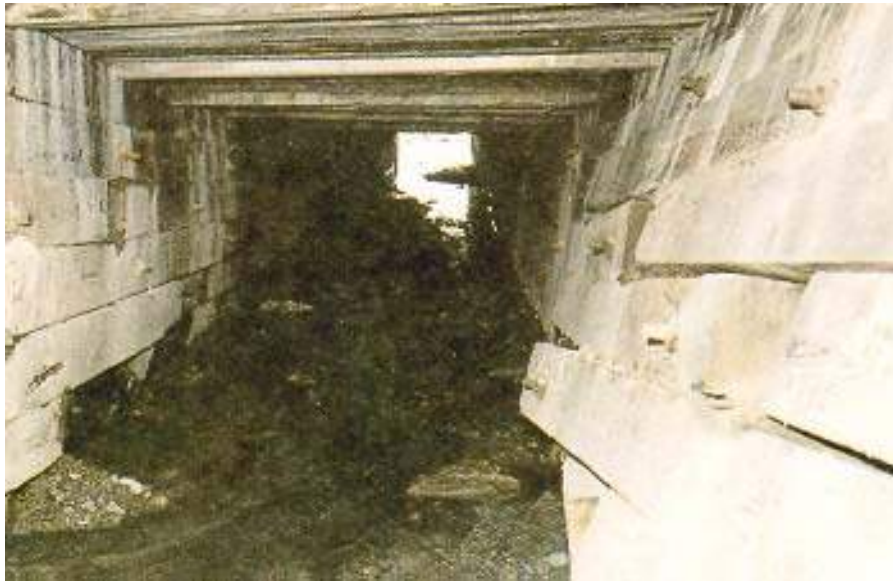
Figure 8.7(c) Wood Culvert

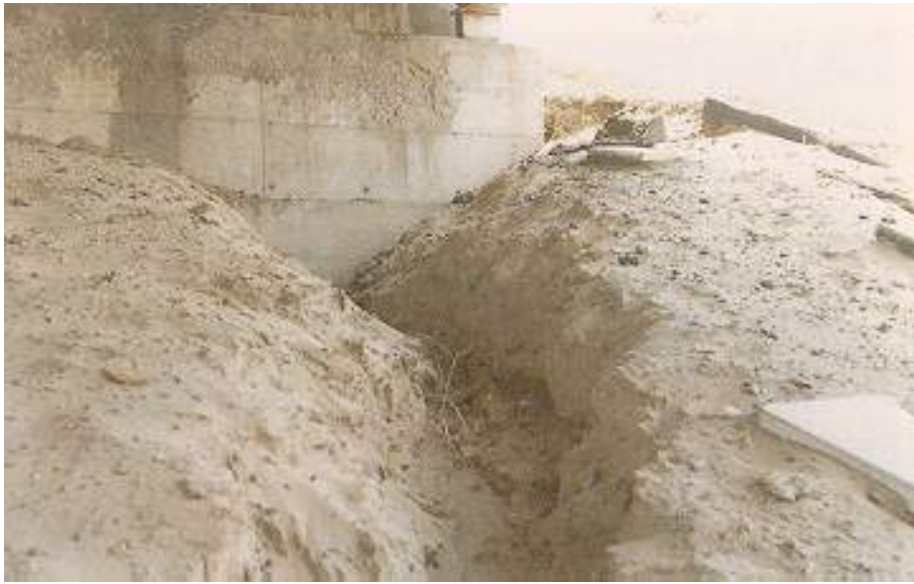
Figure 8.9(a) Embankments

- Minor movement has stopped. Embankment is essentially stable.

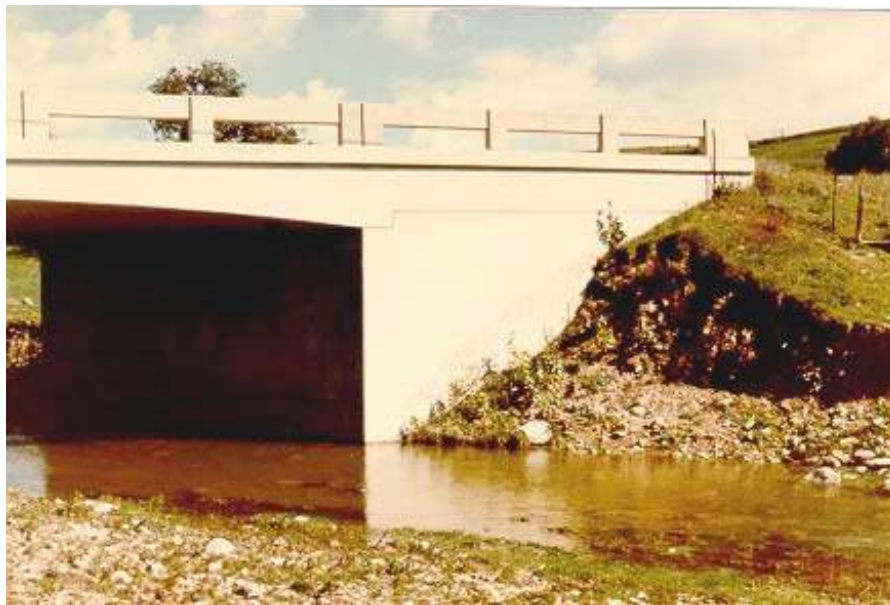
Figure 8.9(b) Embankments

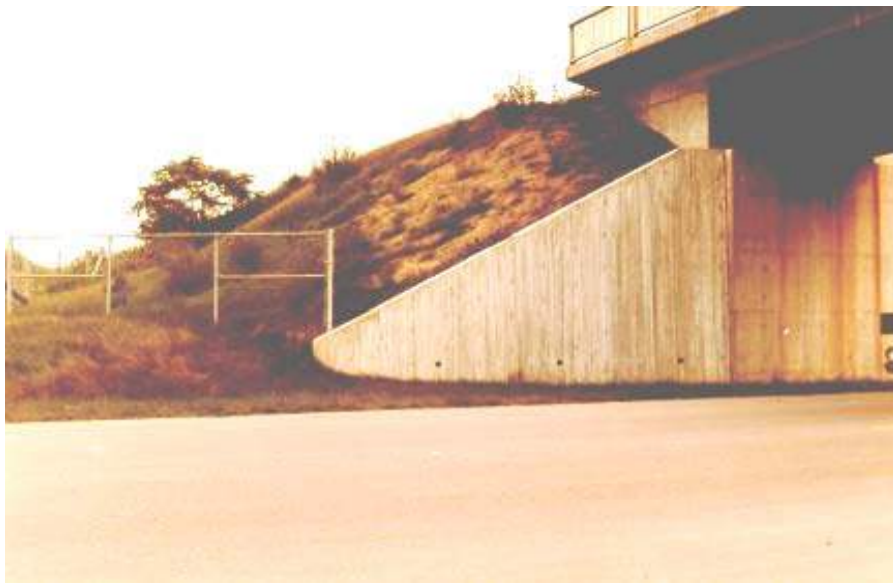
Figure 8.9(e) Grass Slope Protection

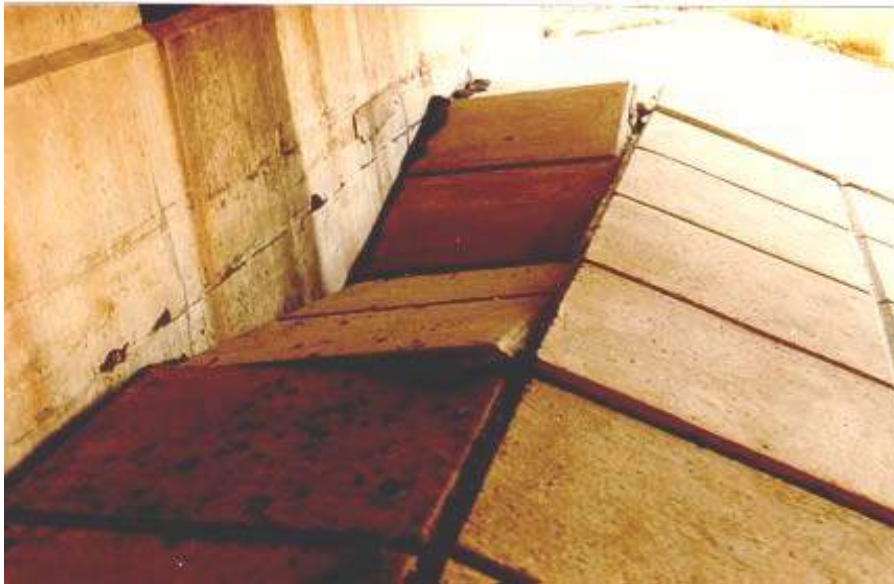
- Loss of protection to 20% of the embankment.

Figure 8.9(f) Cast-In-Place Concrete Slope Protection

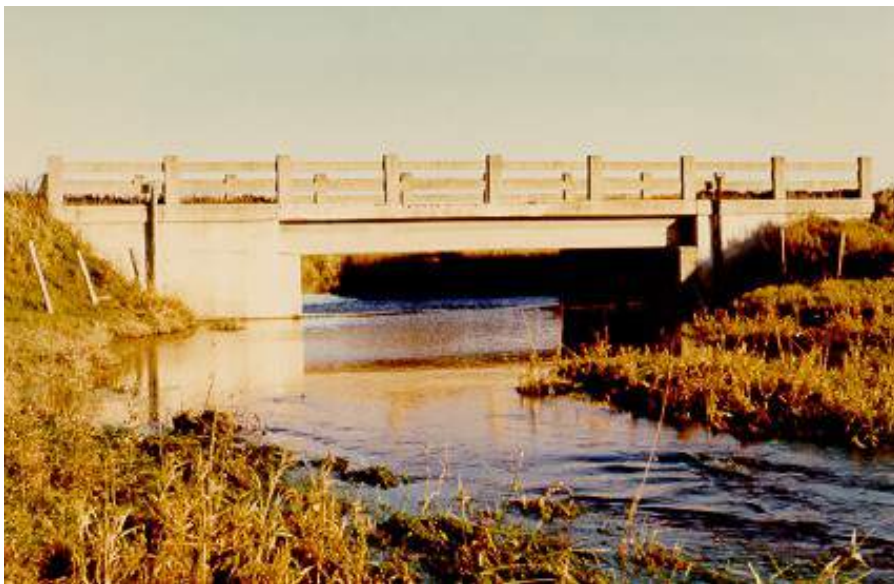
Figure 8.9(i) Streams

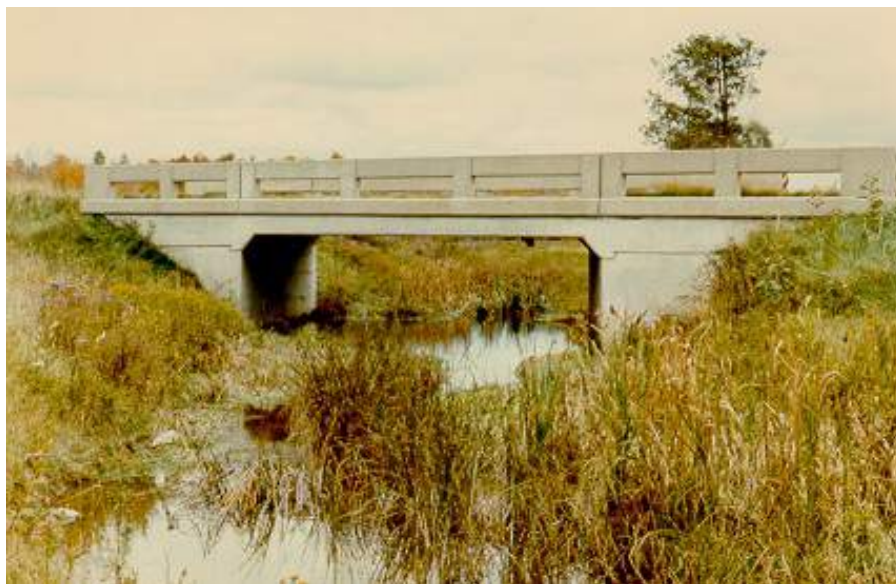
- Stream encroaching against wingwall and substructure with severe erosion of embankment and scour under the foundation.

Figure 8.9(j) Streams

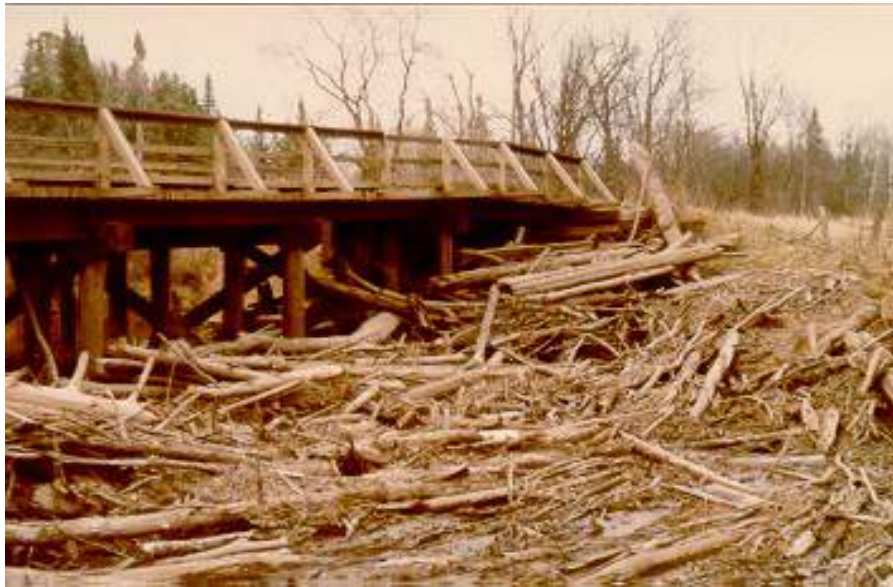
Figure 8.9(l) Streams

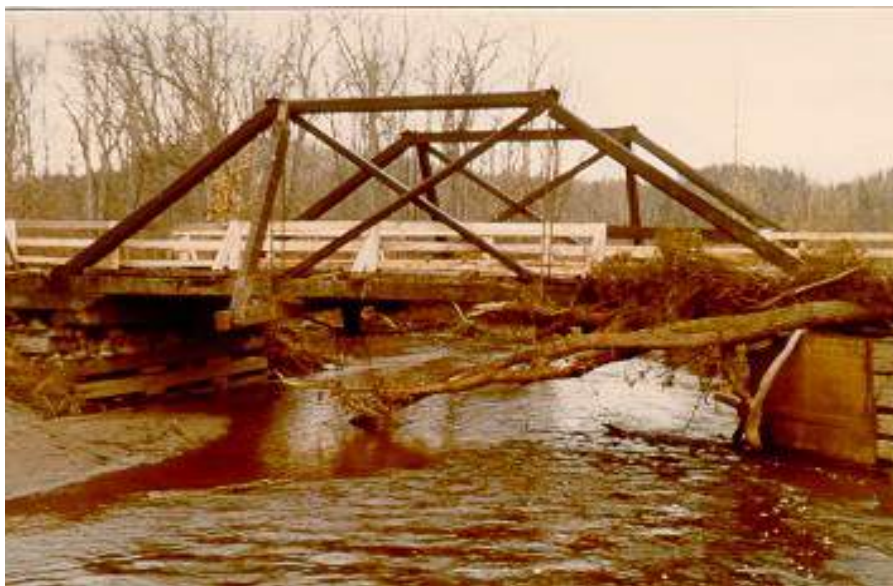
- Debris carried and deposited against structure after a flood causing substantial damage to piles and blocking stream flow.

Figure 8.9(m) Streams

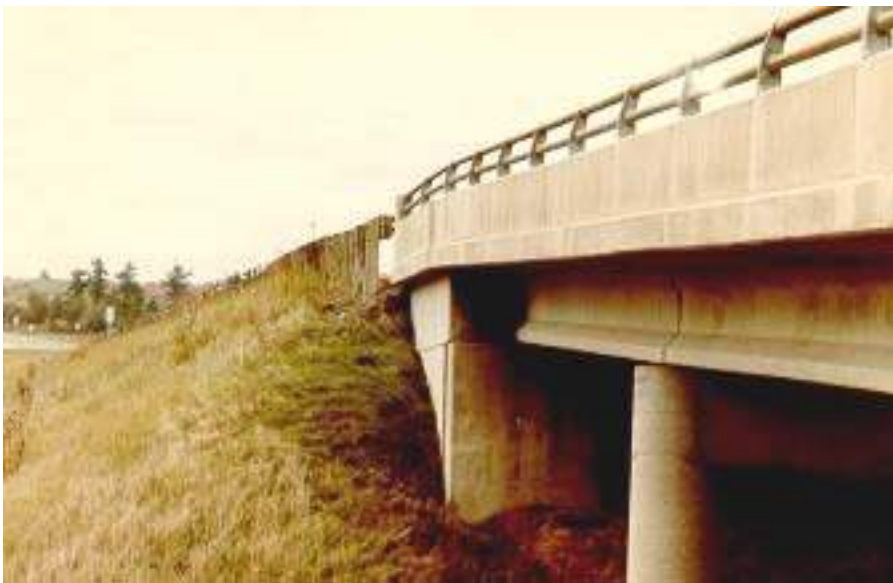
Figure 8.10(b) Foundation

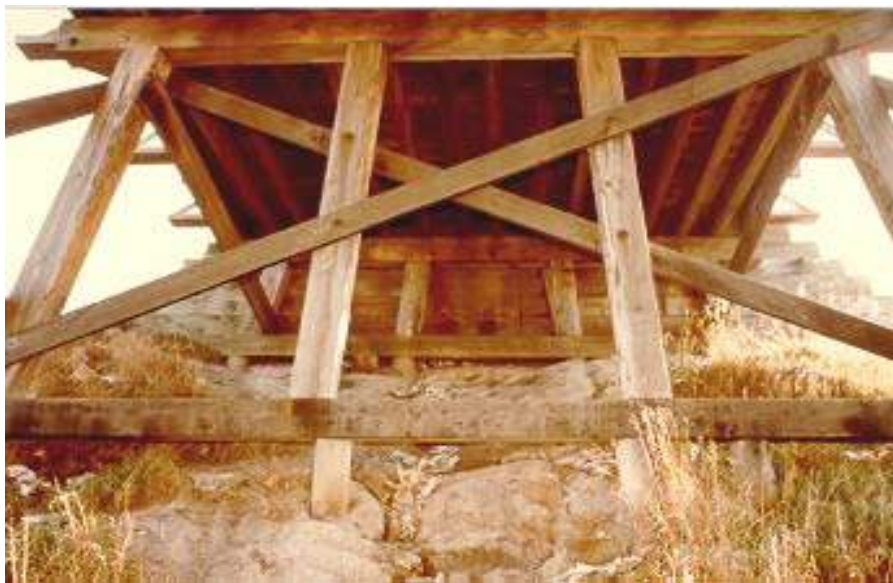
Figure 8.12(d) Wood Trestle

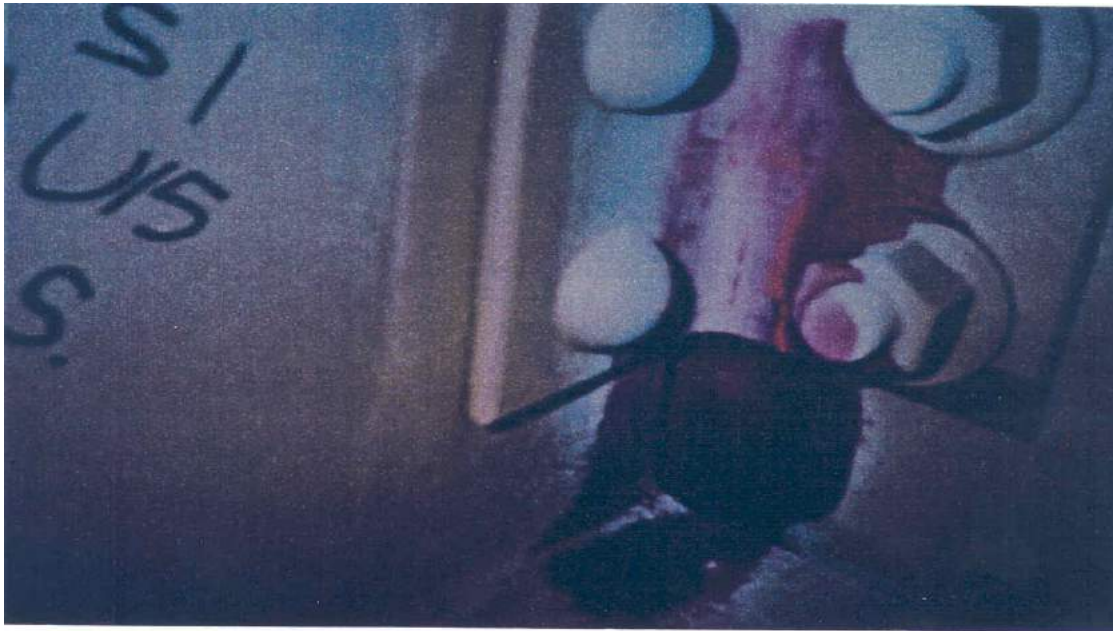
Figure 1.1.1c Surface after developer has been applied. A crack was detected by the small thin red line (bottom right of the weld).

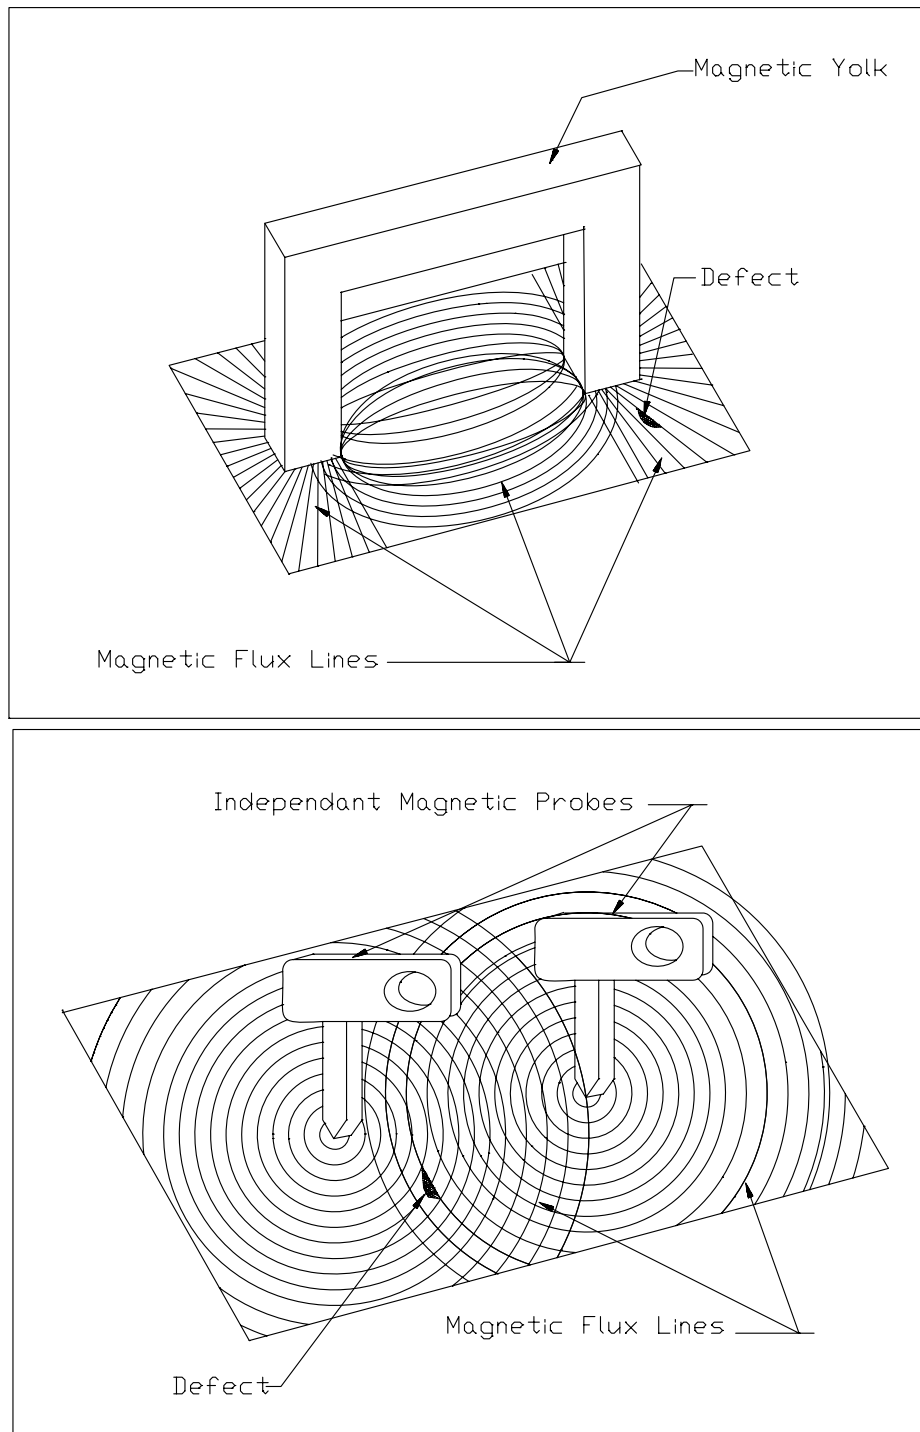
Figure 1.1.2a Typical units used for generating magnetic fields to locate any defects. Top: Yoke; Bottom: Prods.

Figure 1.1.2a shows units used for producing a magnetic field and figure 1.1.2b illustrates how the yokes are used in conjunction with particle application for inspection.

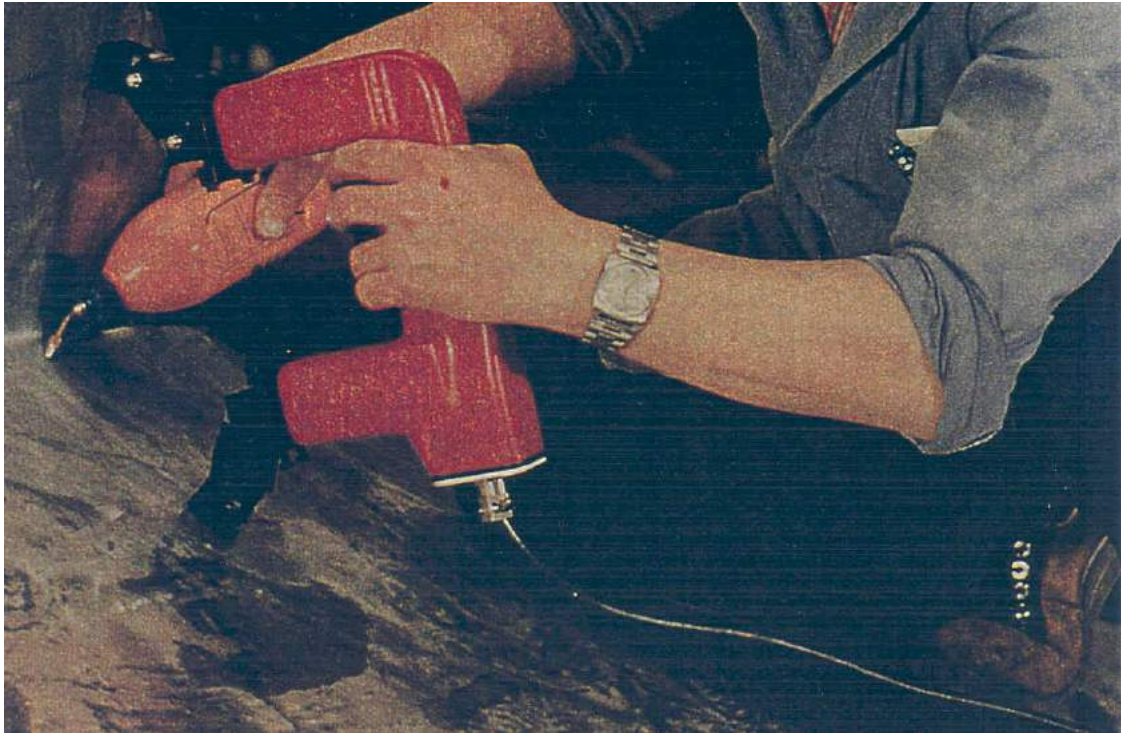
Figure 1.1.2b Typical application of magnetic particles and field generator (yoke).

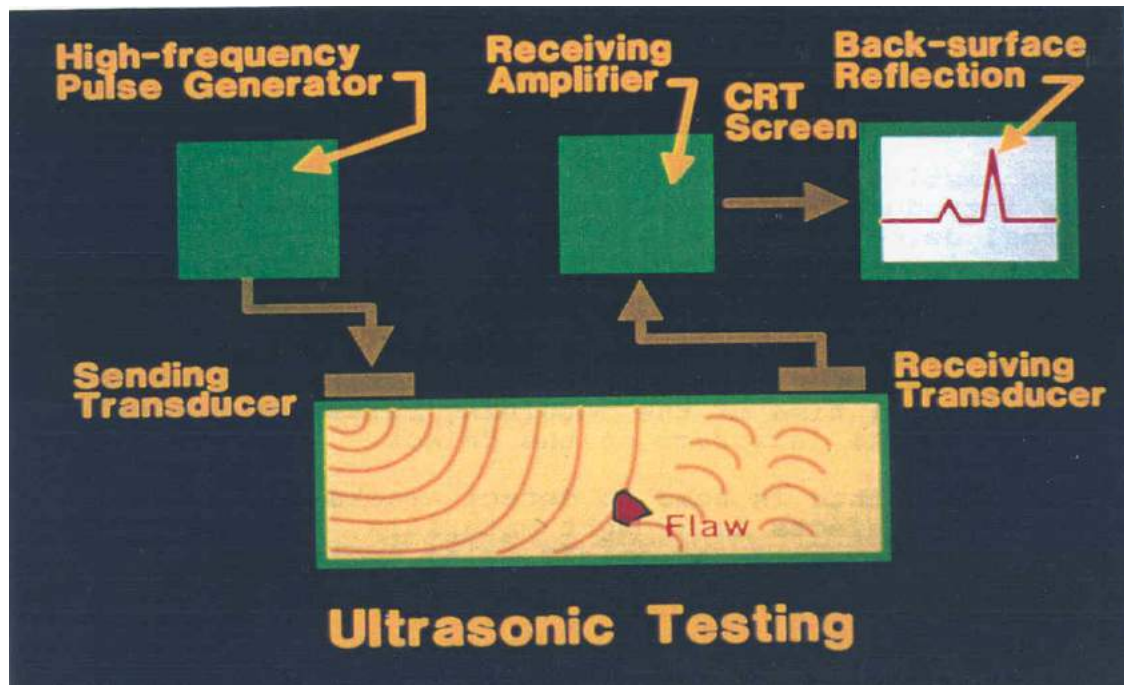
Figure 1.1.3a Schematic of ultrasonic testing equipment

A schematic of ultrasonic testing is shown in figure 1.1.3a and the application of the instrument in figure 1.1.3b & 1.1.3c.

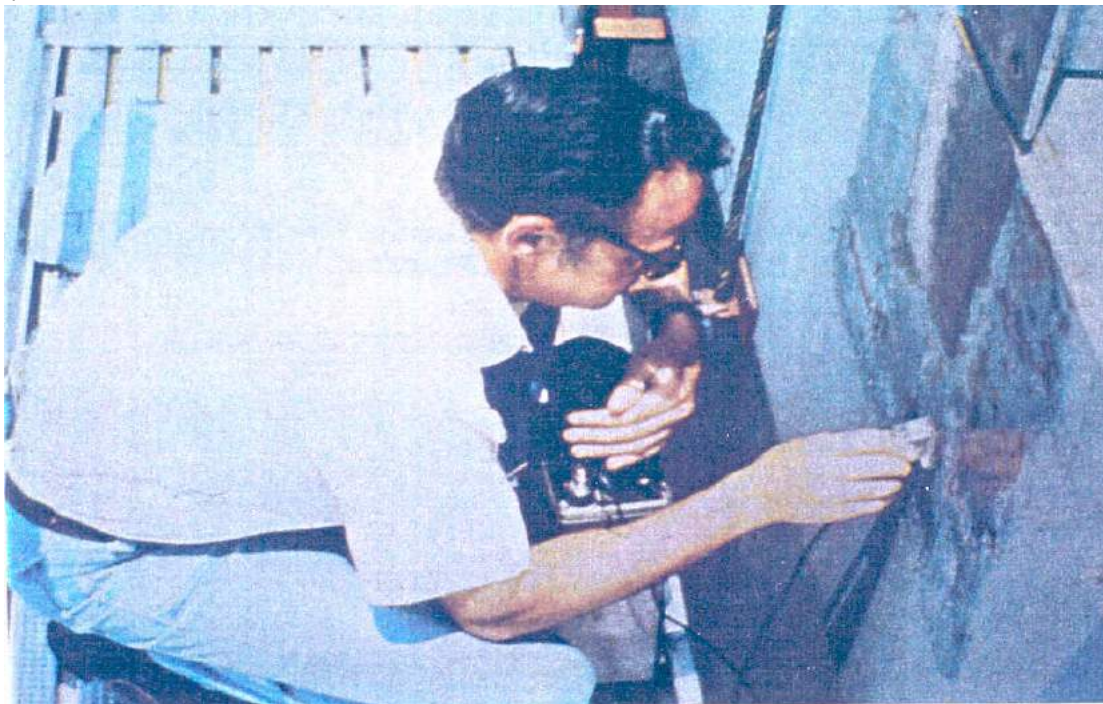
Figure 1.1.3b Application of ultrasonic testing equipment. Component was being inspected for voids and metal defects.

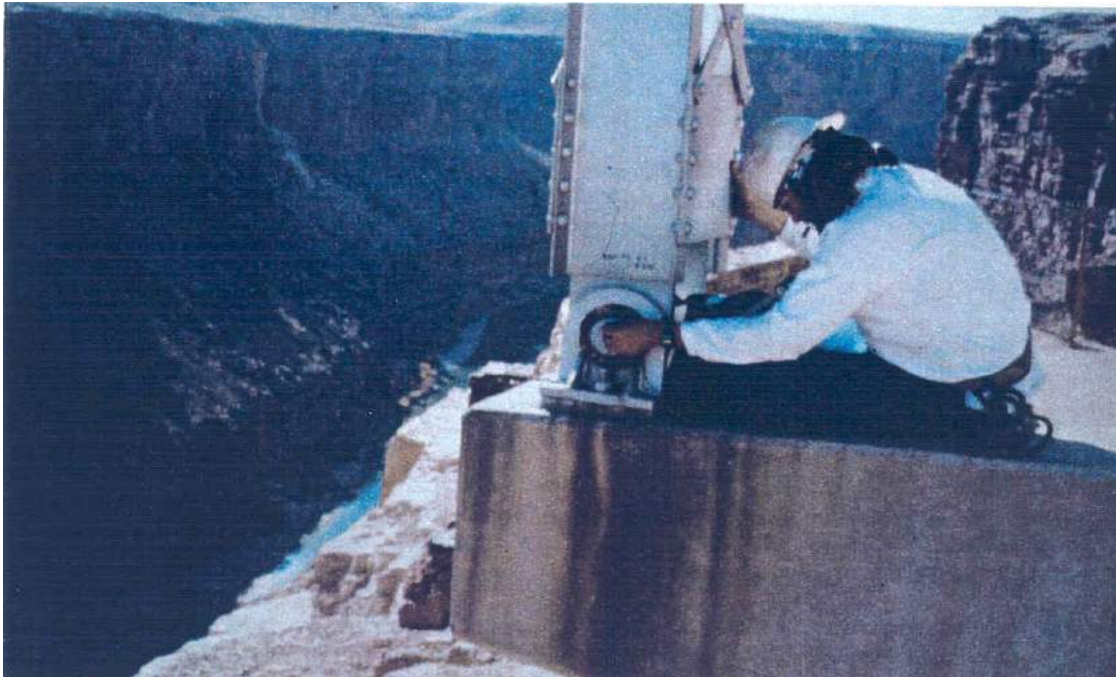
Figure 1.1.3c Ultrasonic testing of a bridge pin.

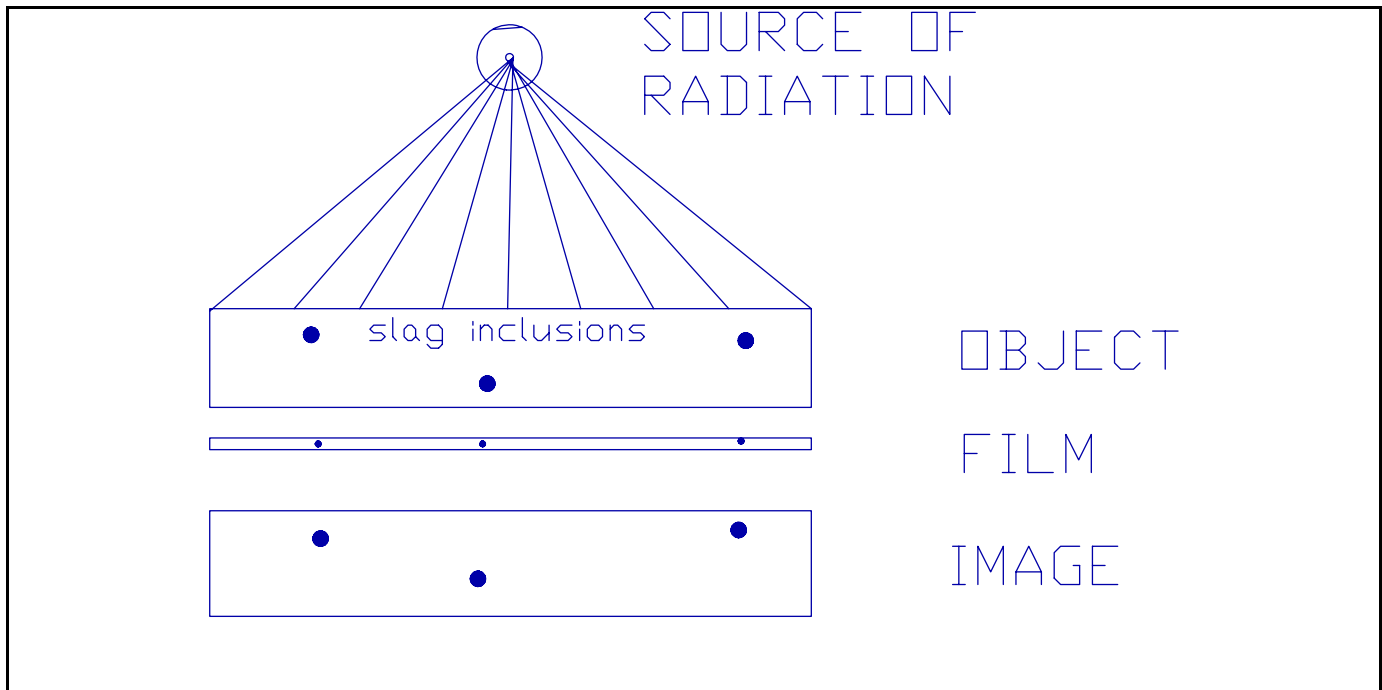
Figure 1.1.5a Schematic of typical radiographic equipment.

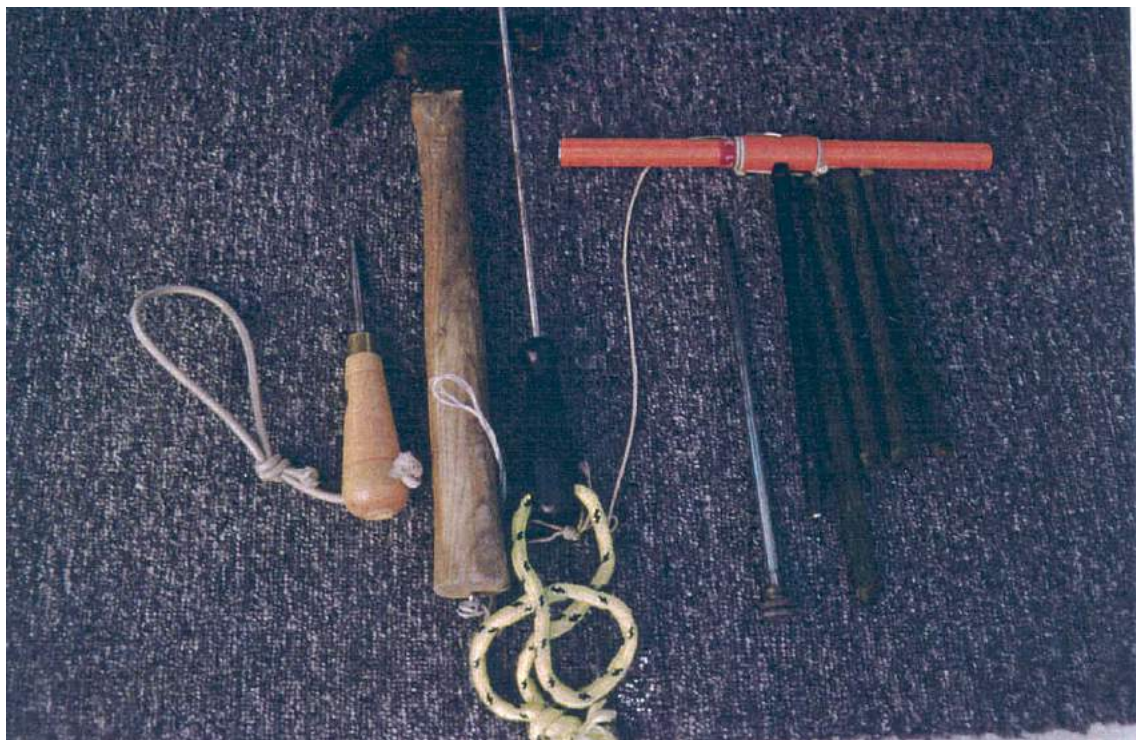
Figure 2.1 Typical tools used for testing wood condition.
Left to Right: pick, hammer, probe, coring
tool, boring tool and treated wood plugs.

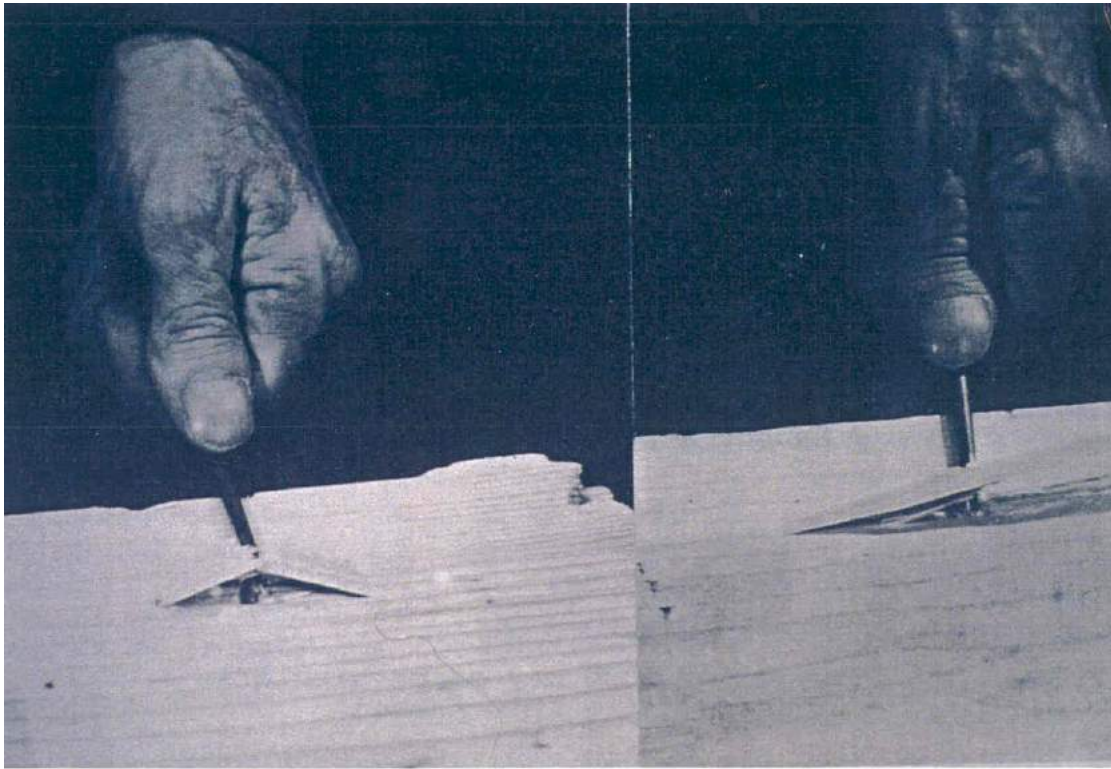
Figure 2.2.2 Pick test: The picture on the left hand side illustrates decayed wood while the one on the right shows sound wood with no decay

In this test, a pointed pick, screwdriver or awl is driven a short distance into the wood, transverse to the grain, to pry out a sliver of wood from near the edge of a component. Sound wood has a fibrous structure and pries out as long splinters, while decayed wood breaks abruptly and crumbles into small pieces (figure 2.2.2).

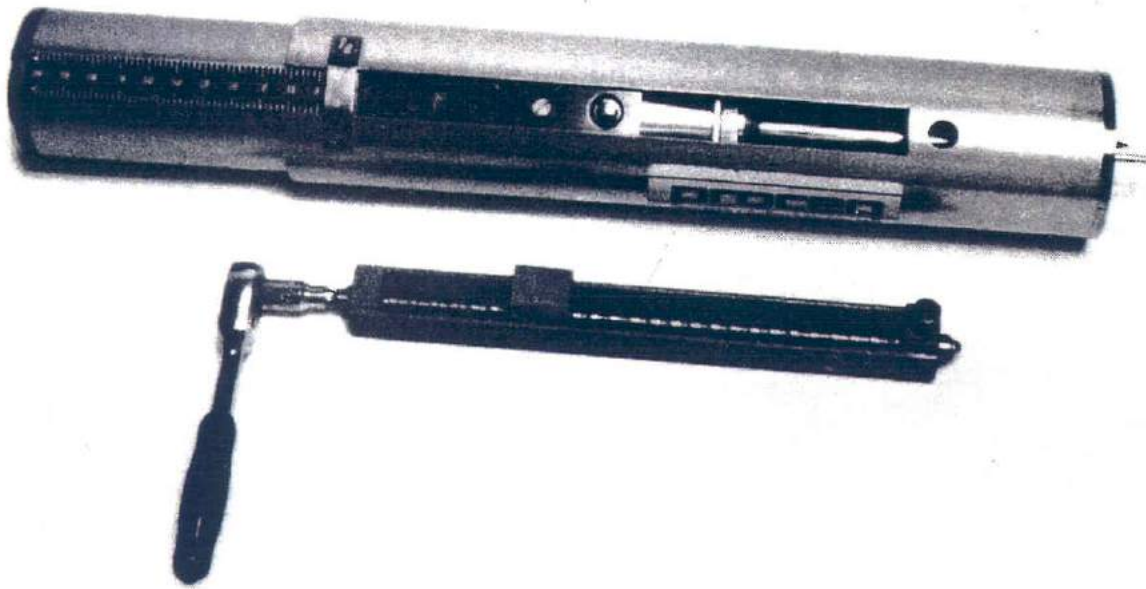
Figure 2.2.3 Typical Pilodyn used for assessing wood condition.

A pilodyn (figure 2.2.3) is a spring-loaded pin device that drives a hardened steel pin into the wood. The depth of pin penetration is used as a measure of the degree of decay.

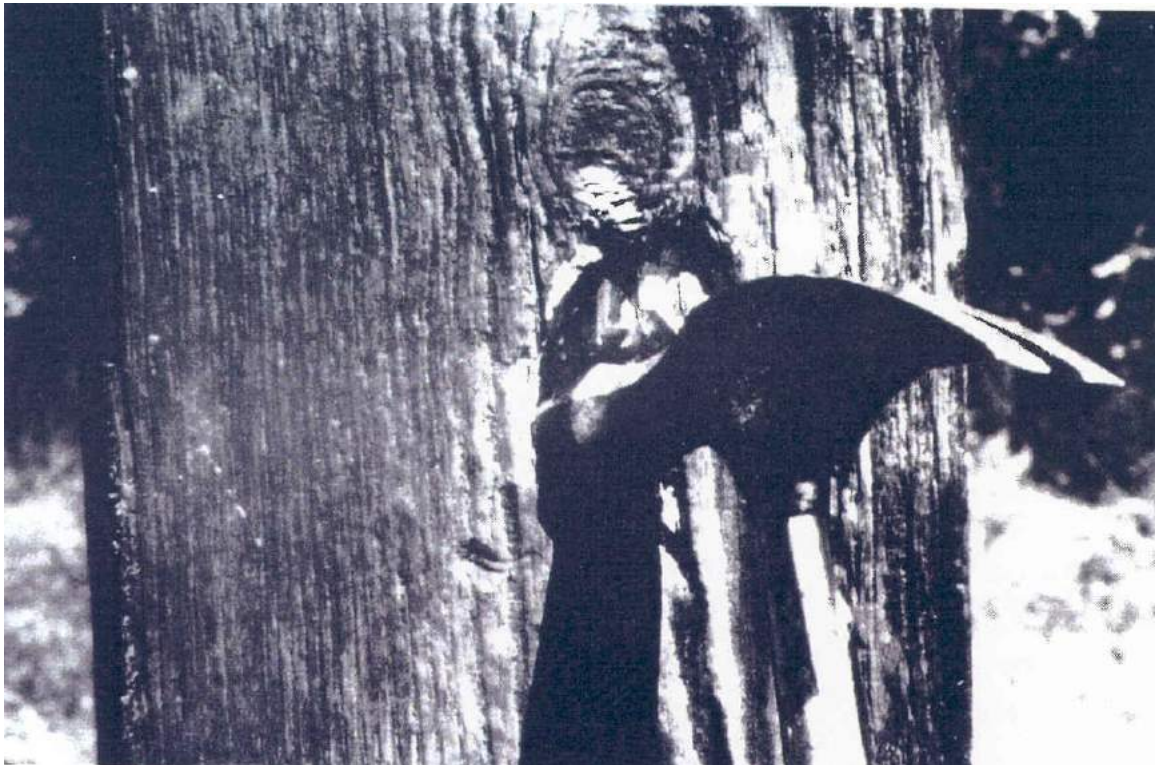
Figure 2.3.2 Simple use of a hammer to sound a wood timber.
Decay is indicated by a hollow sound.

Sounding is a commonly used method and involves striking the surface of the component with a hammer, or other similar object, and assessing the resulting tonal quality. A dull or hollow sound may indicate the presence of internal voids due to decay (figure 2.3.2). However, other factors may be present which may make clear identification difficult.

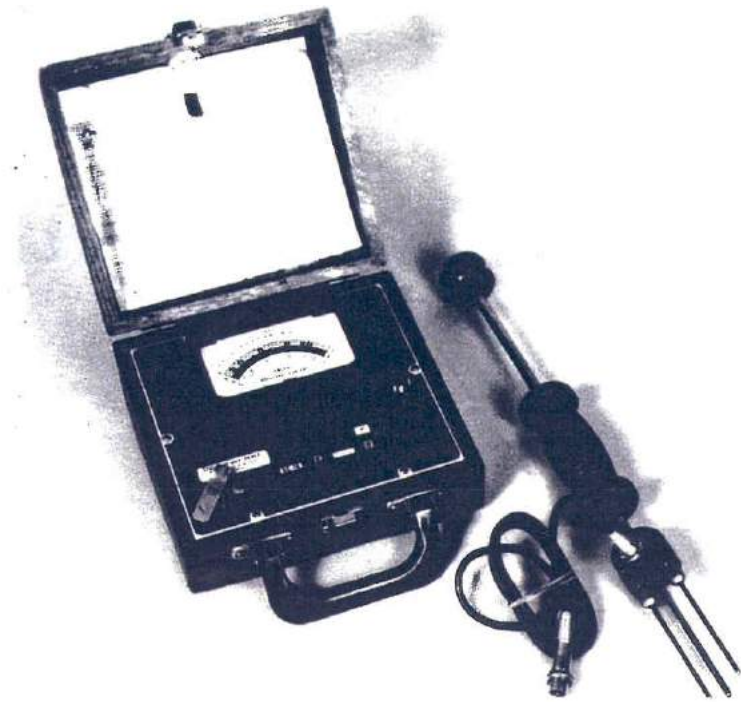
Figure 2.3.3a Typical resistance-type moisture meter.

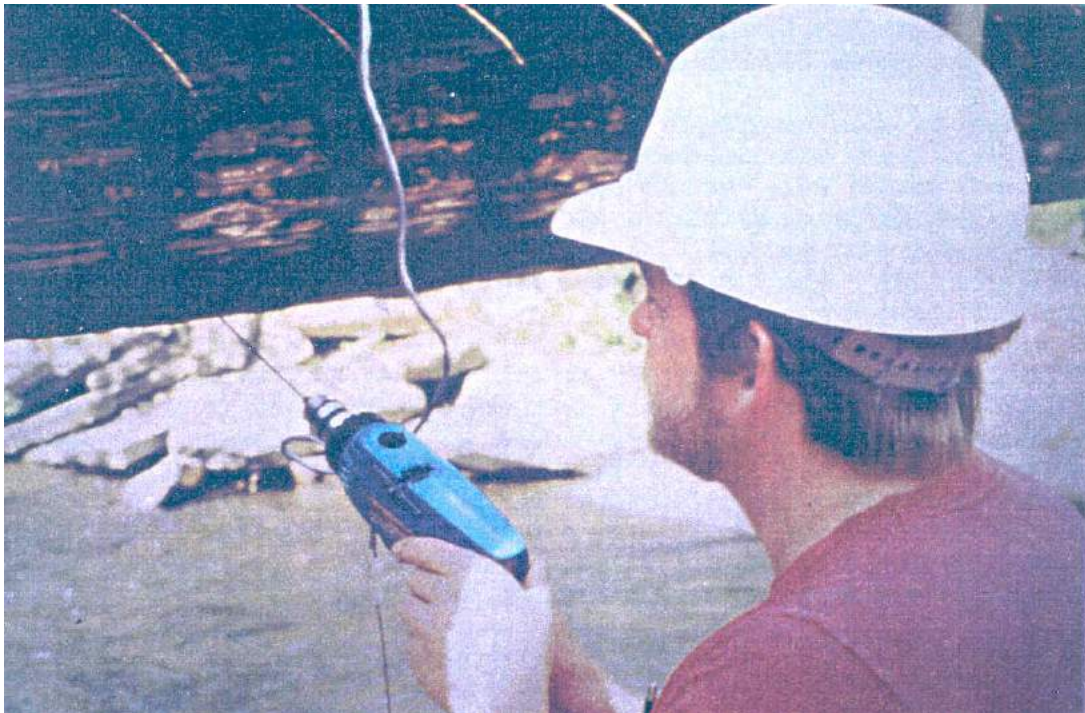
Figure 2.3.3b Drilling of the wood beam in preparation for the shigometer probe.

An alternative instrument to check for moisture is a shigometer. The shigometer uses a pulsed current to measure changes in electrical conductivity associated with wood decay. A small hole is drilled into the wood (figure 2.3.3b) and a probe is inserted into the hole (figure 2.3.3c). The probe measures zones or regions of decreased resistance. If the readings drop 50% to 75% to that of sound wood, the region is drilled and cored to determine the extent and nature of the decay.

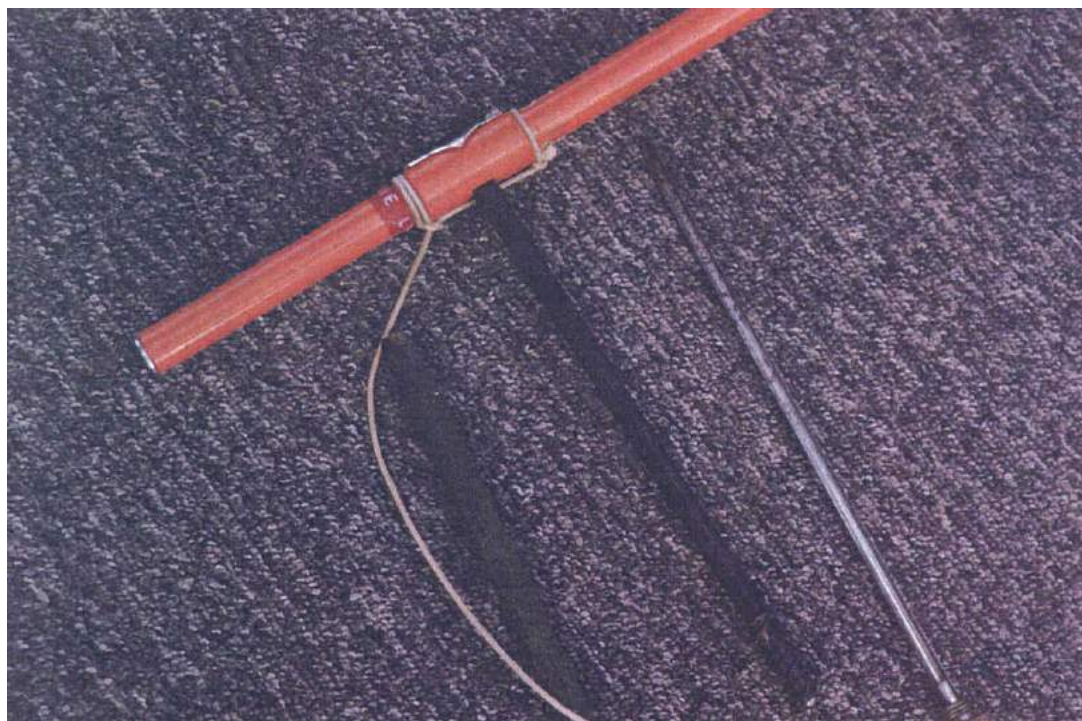
Figure 2.3.4a Equipment used for boring and coring. The piece of pressure treated wood is used as a plug to repair damage done by boring.

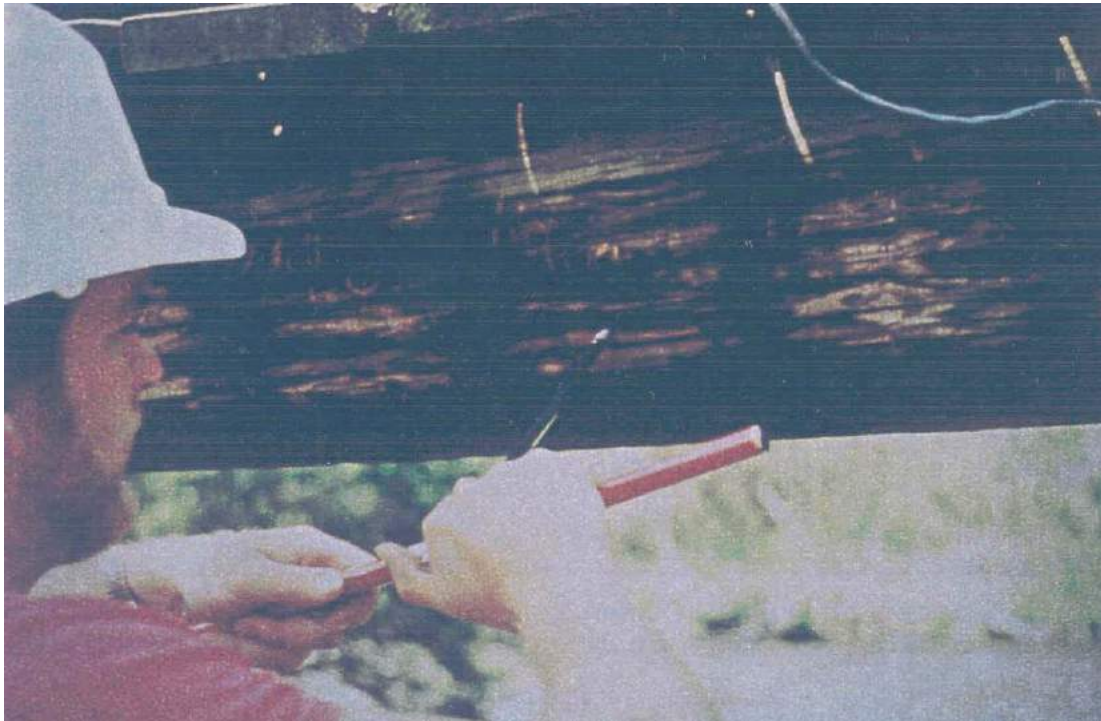
Figure 2.3.4b Simple application of the boring tool.

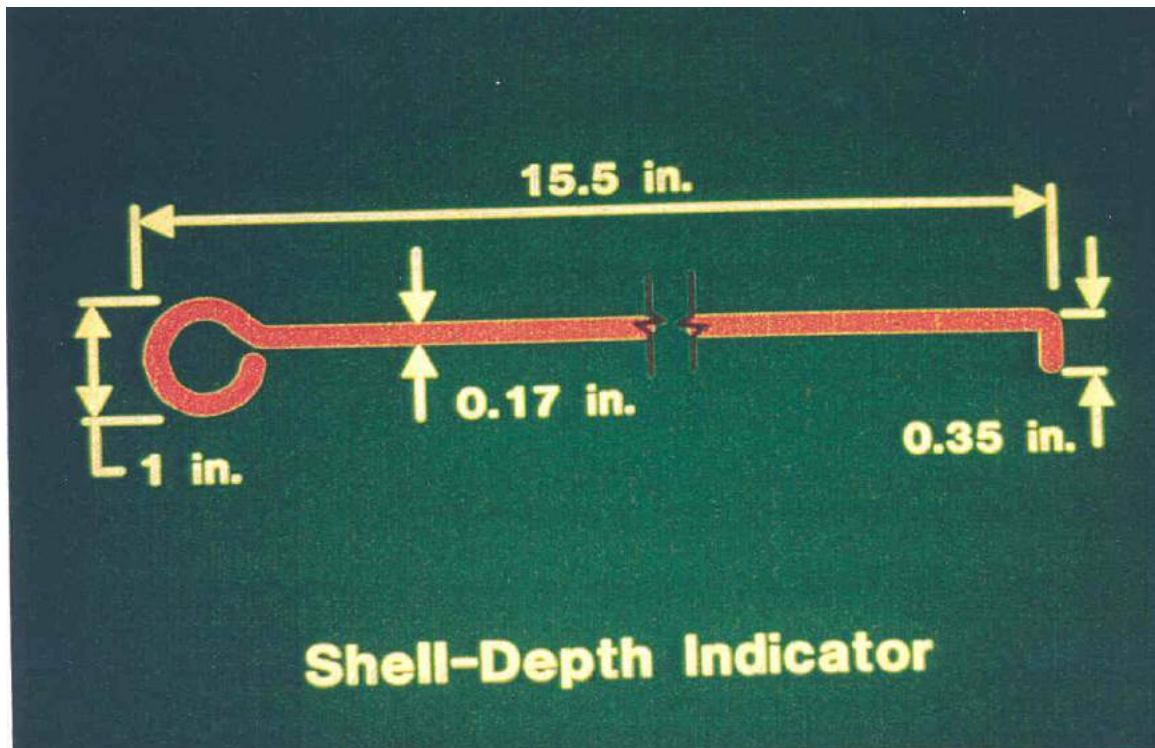
Figure 2.3.5a Schematic of a shell-depth indicator.

A shell-depth indicator is a metal bar or rod which is notched or hooked at one end and inscribed with ruled markings along its length (figure 2.3.5a). The hooked end is inserted into the inspection hole and pulled back along the side of the hole. As it is removed, the hook will be easily pulled through voids and decayed areas but will catch on the edges of solid sections (figure 2.3.5b). The inspector can thus determine the depth and extent of decay and remaining solid portions as read from the ruler markings.

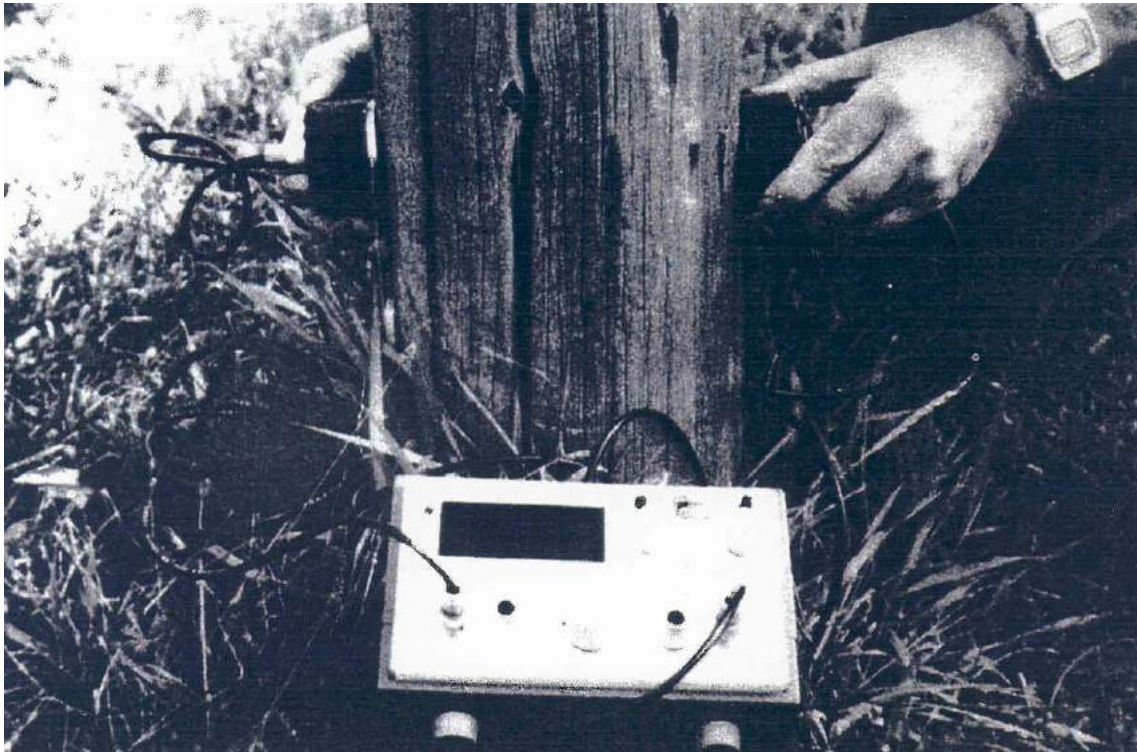
Figure 2.3.6 Typical sonic testing equipment.

A typical device used for sonic testing is shown in figure 2.3.6
