Ontario Structure Inspection Manual (OSIM)

Ministry
of
Transportation

POLICY, PLANNING & STANDARDS DIVISION
ENGINEERING STANDARDS BRANCH
BRIDGE OFFICE
October, 2000

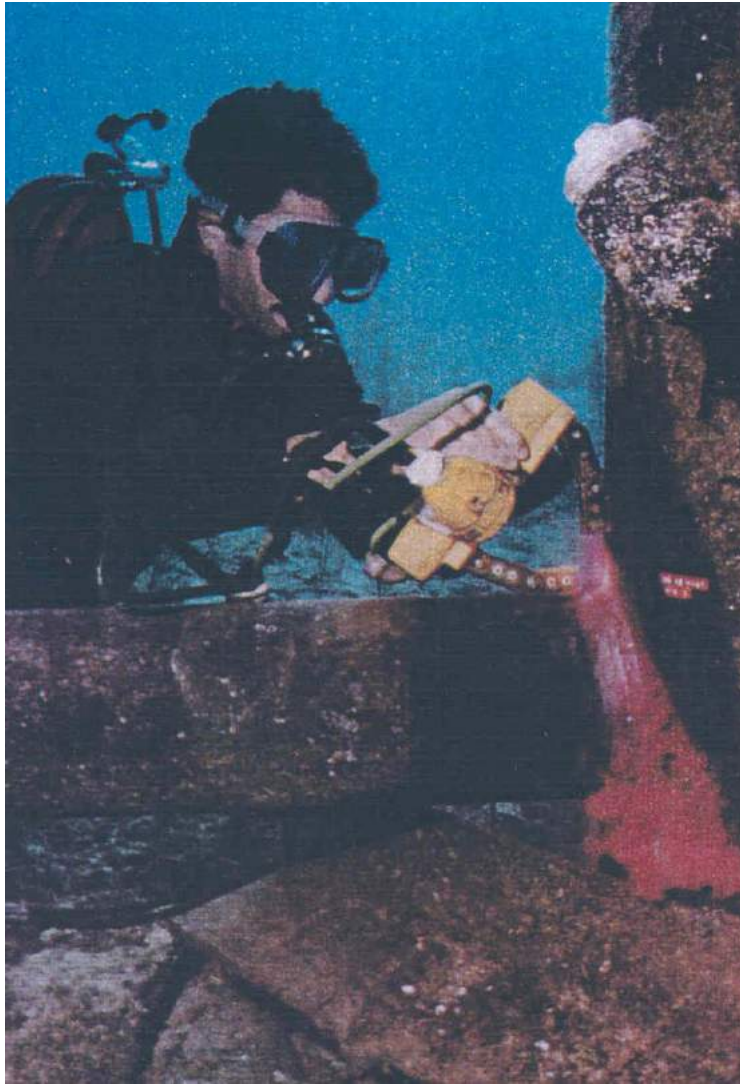
Figure 1.4.2 Underwater Magnetic Particle Inspection.

Magnetic particle testing techniques are also used underwater for cracks or discontinuities in the surface of components. The process is the same as used on the surface except the magnetic particles are in a water suspension of fluorescent dye (figure 1.4.2). The flux leakage at the defect creates an accumulation of the coloured particles indicating location and size. This deposit can be measured and photographed to create a permanent record. The surface still must be cleaned with a wire brush or a water-jet.

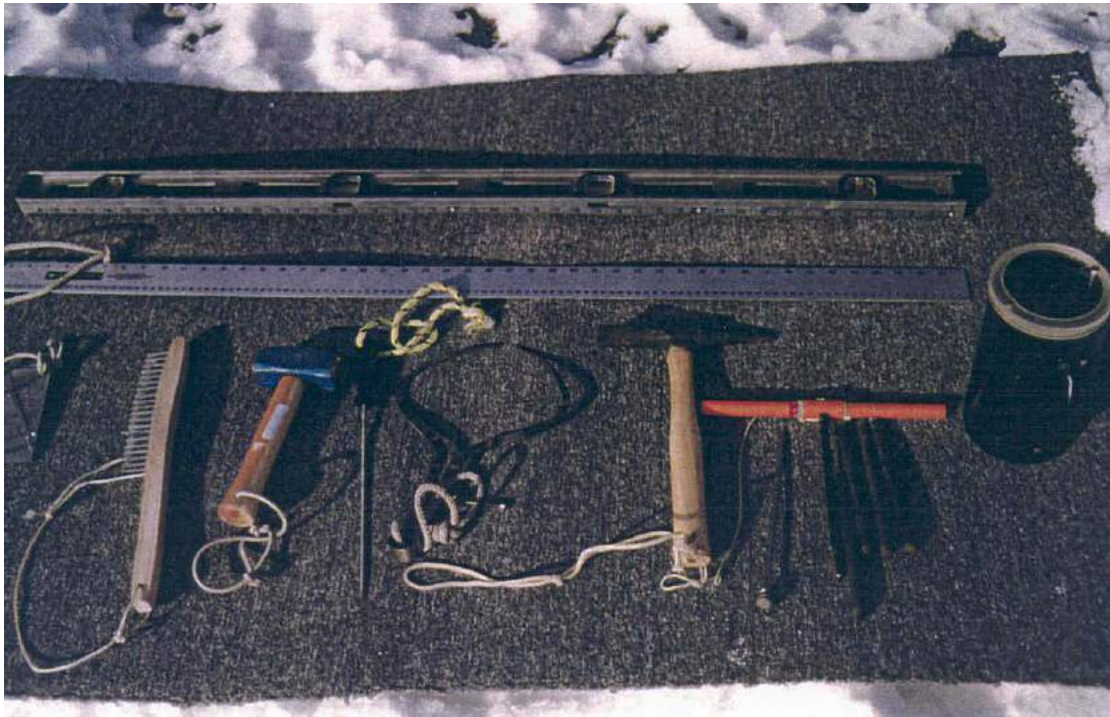
Figure 2.1 Typical Hand Tools for Underwater Inspection

A variety of equipment is required for underwater inspection purposes and this can include almost all hand tools normally used during a structural inspection of any structure above water. Those most commonly employed underwater are illustrated in figure 2.1.

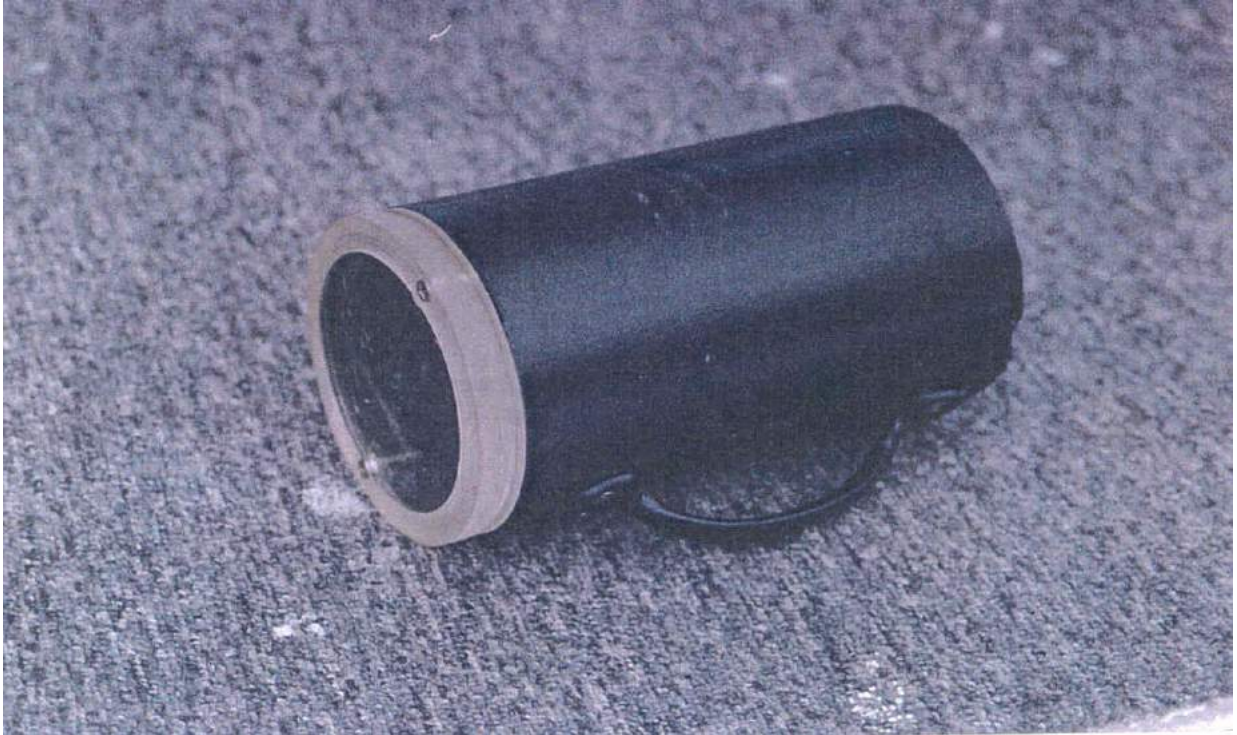
Figure 4.2 Underwater Viewing Tube

Where the water depth is relatively shallow (less than about a metre), the river bottom is reasonably hard and there is little or no current, the submerged components can be inspected during the regular routine inspections with the inspector wearing chest waders and a personal floatation device. The critical area for observations is at and immediately below the water line, and this can be readily inspected while wading. In clear water, observation below the surface can be made with the use of a simple viewing tube as illustrated in Figure 4.2 or with a conventional face mask. Where visibility below the surface is limited, the critical area can be examined tactually. During a wading inspection, the condition of the stream bed adjacent to the structure can also be evaluated.
